BRIBIE ISLAND EROSION AND BREAKTHROUGH

Independent expert review pursuant to the Terms of Reference

PART 2 - RECOMMENDED IMMEDIATE OPTIONS

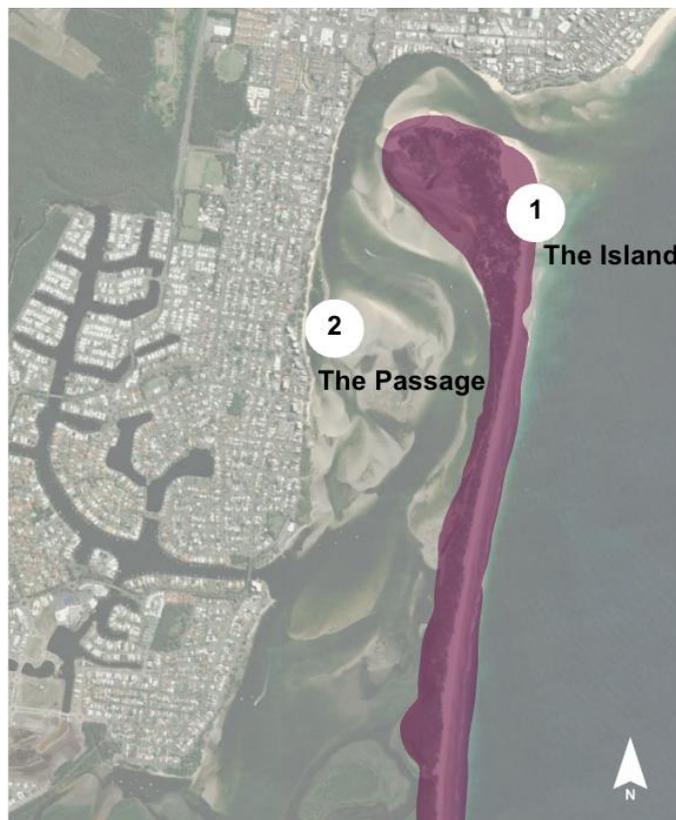
Figure 1: Two geographic areas defined for action planning - ‘The Island’ and ‘The Passage’

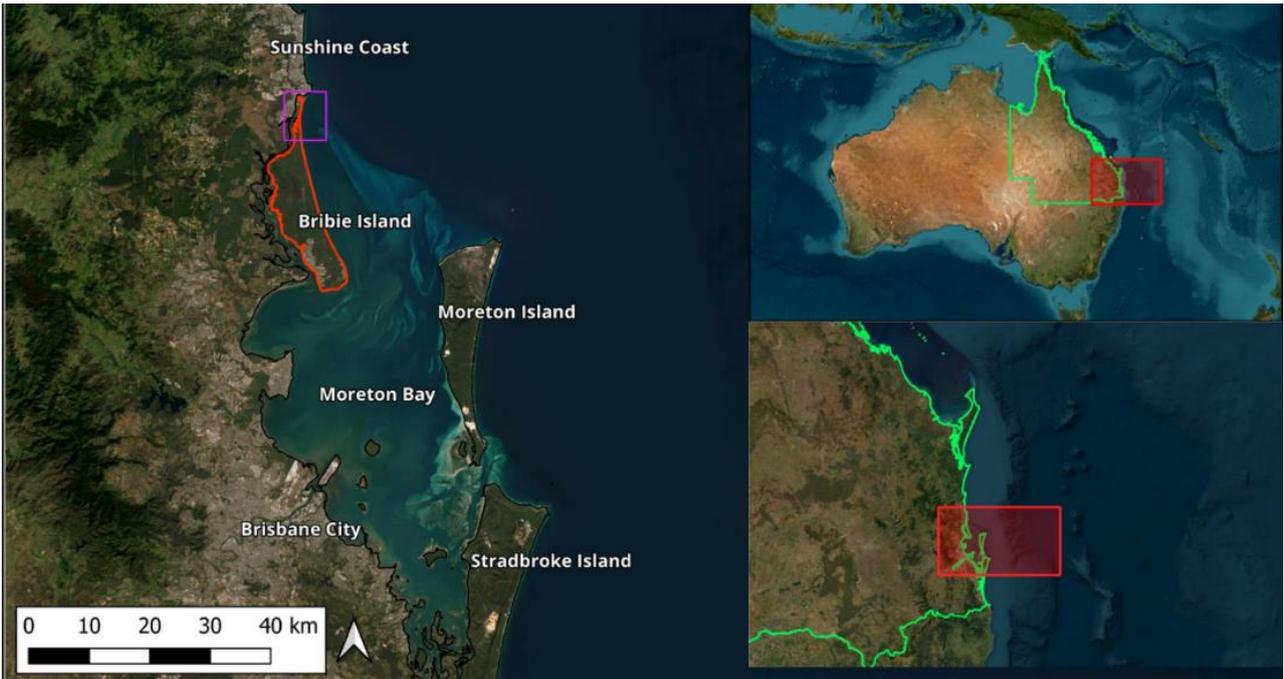
Figure 3: Aerial image of site (Waterhouse, A., 2023).

Bribie Island is a large sand island located off the coast of Queensland, Australia (Figure 3 & Figure 4), forming a natural barrier between the Coral Sea and the Pumicestone Passage. The site of interest specifically refers to the northern spit of Bribie Island and its interface with the mainland at Golden Beach, within the Sunshine Coast Region Local Government Area. This location plays a critical role in the coastal and estuarine dynamics of the northern Pumicestone Passage, which is a tidal waterway extending between Bribie Island and the mainland. The northern end of Pumicestone passage is connected to the ocean. This shallow tidal entrance is generally located at Caloundra Head but migrates southward at times.

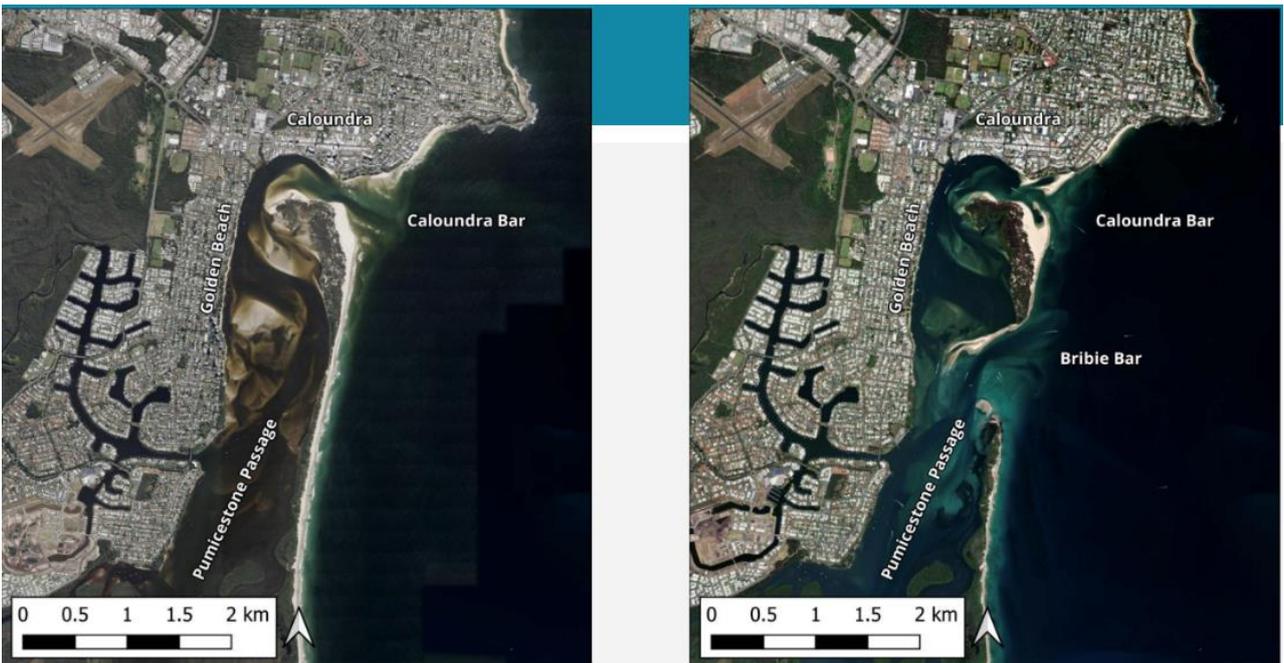
Figure 4: Aerial image of the site (Waterhouse, A., 2023).

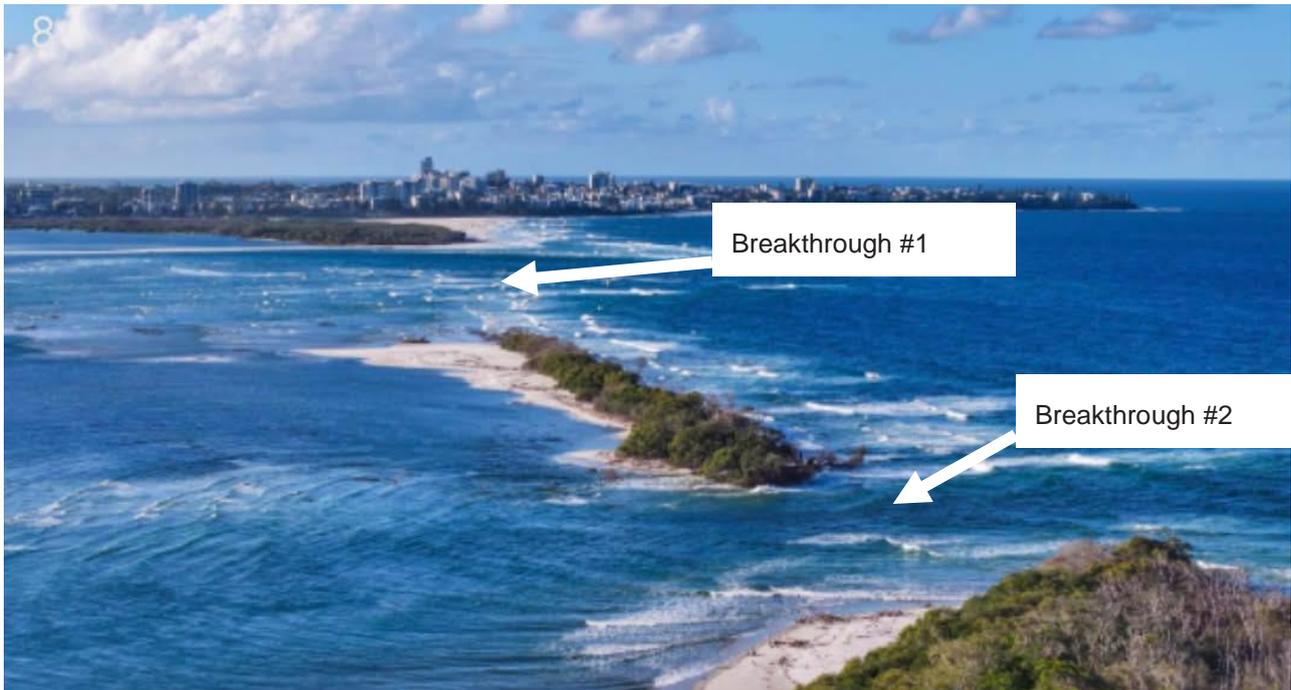
Figure 9: Bribie Island Breakthrough #1 & #2 on May 7, 2025 (Bluey's Photography Facebook Account, 2025).

The island is now a series of smaller islands, highlighted well in the aerial image below from 7th of May 2025.

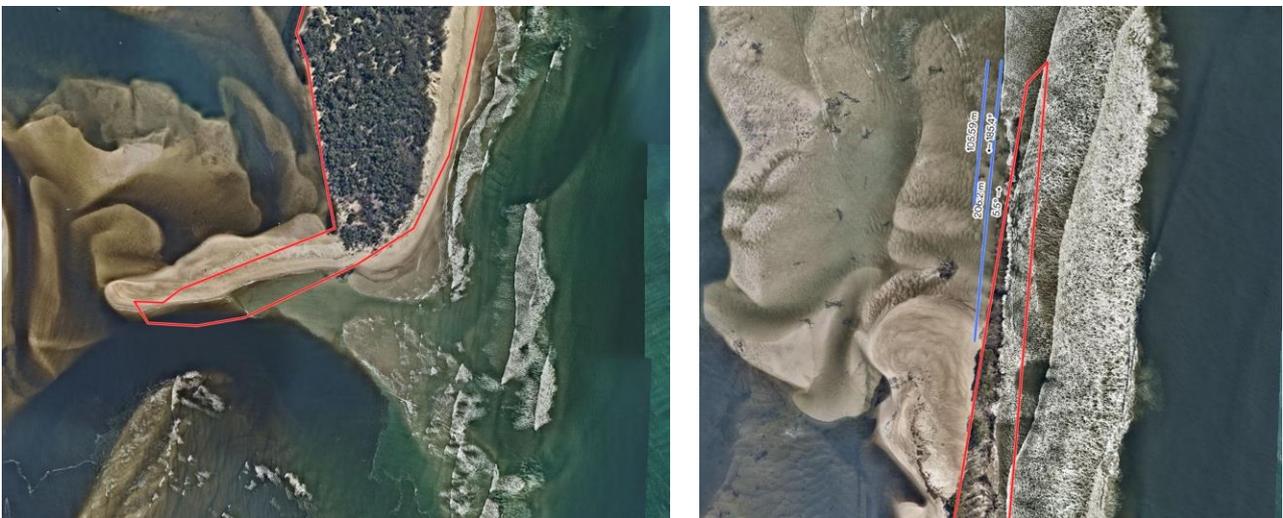
Figure 10: Aerial images of Breakthrough #1 on April 17, 2025 (Nearmap, 2025).

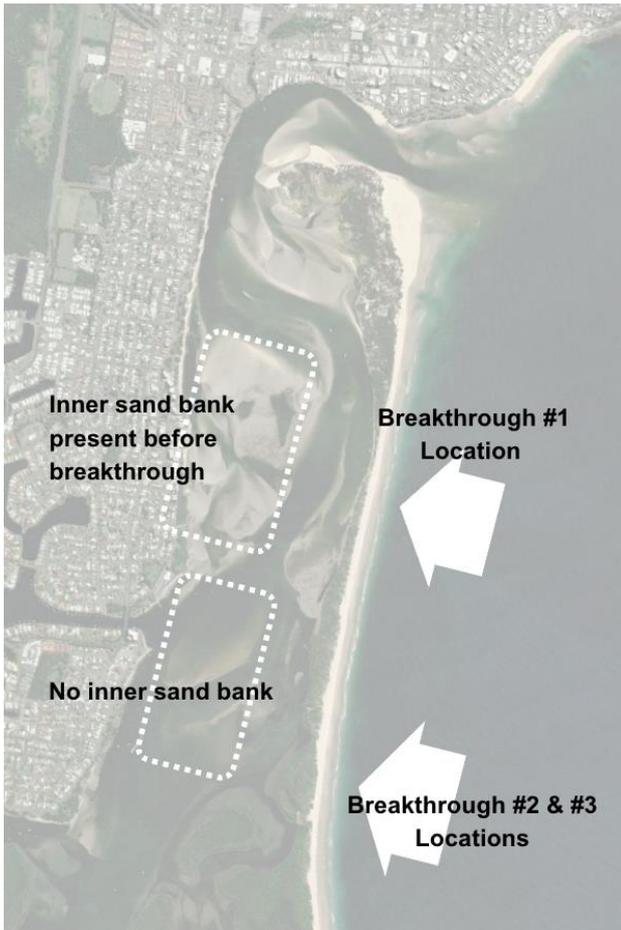
Figure 11: Location of breakthrough sites in relation to sandbanks in The Passage (pre Breakthroughs) (Google Earth aerial, 2018).

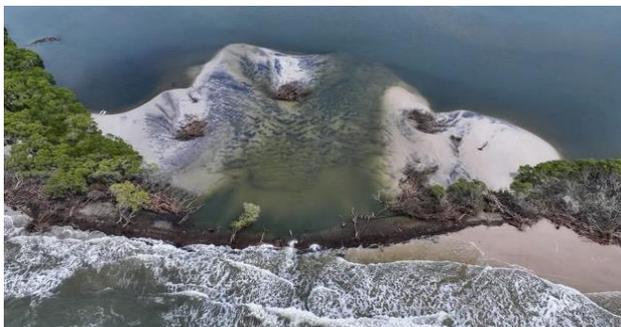
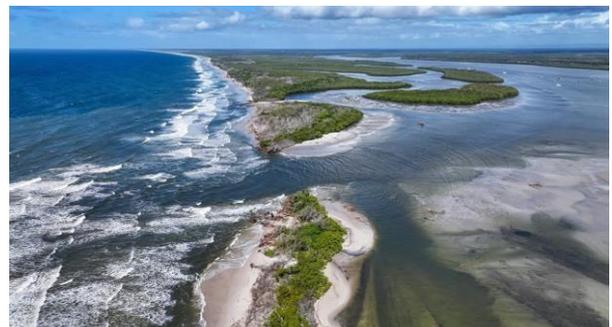
Figure 12: Aerial images of breakthrough. *Left:* March 11, 2025 - During Tropical Cyclone Alfred conditions. *Right:* May 7, 2025 - Fully open channel/bar crossing (Bluey's Photography Facebook Account, 2025).

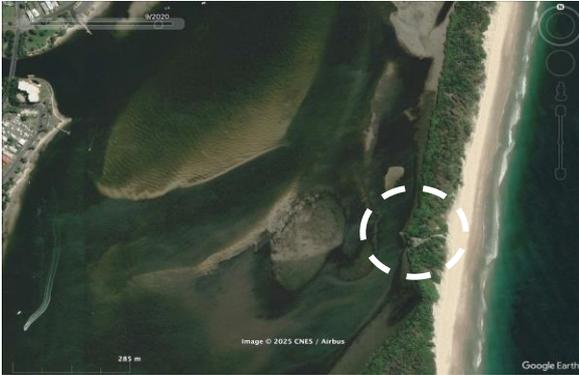
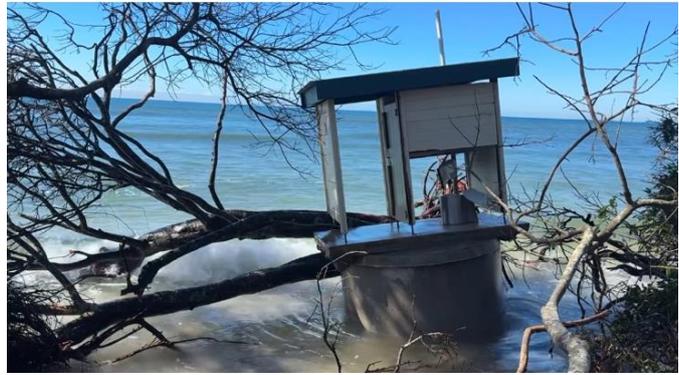
Figure 13: *Left:* Aerial image of the toilet facility (Google Earth, 2025). *Right:* Loss of the toilet facility at Lions Park on April 29th, 2025 (Caloundra Fishing World Facebook, 2025).

The rapid progression of erosion following the breakthrough events now places both recreational and heritage assets at greater risk, underlining the need for updated assessments and potential emergency protection measures.

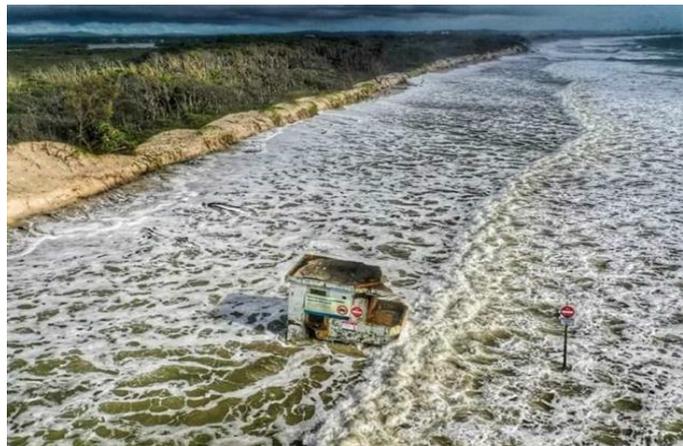
Figure 14: *Left:* Aerial image showing the location of the WWII bunker (Google Earth, 2025). *Right:* Drone image of WWII bunker taken in 2018 (Bluey's Photography Facebook Account, 2018).

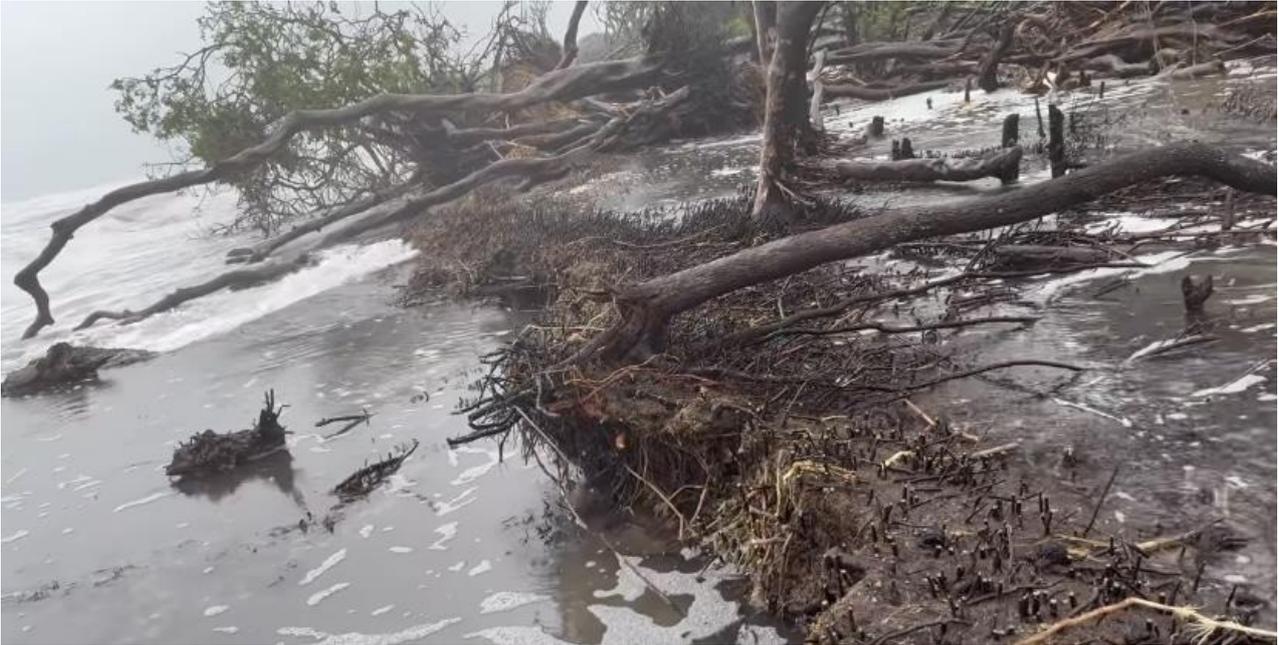
Figure 15: PPCMB showing oceanfront-exposed vulnerable vegetation on May 6, 2025.

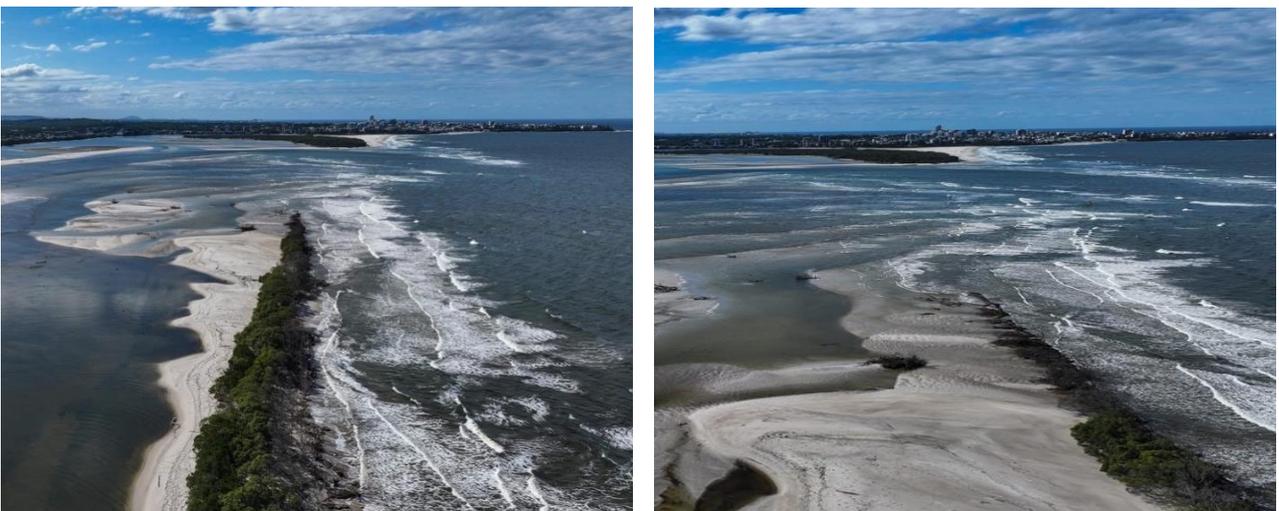
Figure 16: Drone images of the breakthrough. Note the degrading vegetation along the oceanfront, resulting in vegetation loss (right). Once the vegetation is lost, the island transitions into a submerged sand bar (Bluey's Photography Facebook Account, 2025).

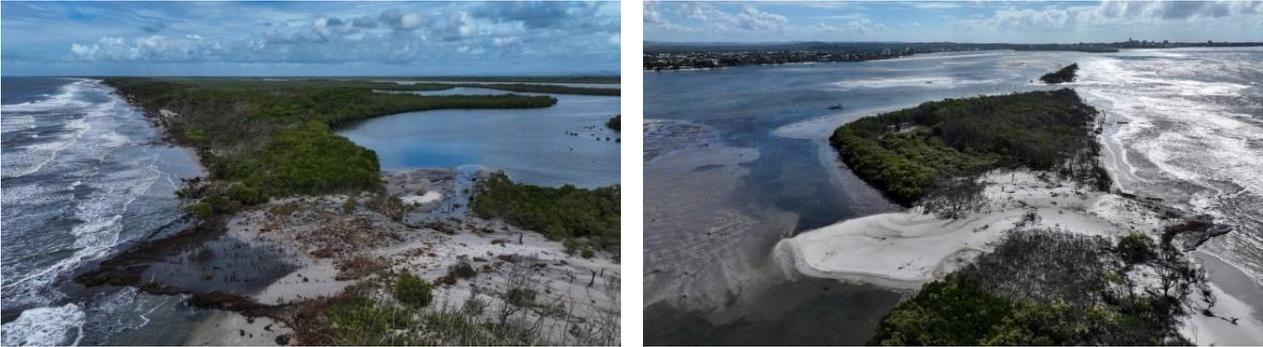
Figure 17: Drone images of Breakthrough #3. *Left:* March 11, 2025. *Right:* May 7, 2025, showing overwash conditions (Bluey's Photography Facebook Account, 2025).

While Breakthrough #3 has not yet fully formed, its progression, especially under further storm or high tide events, poses a significant environmental risk that requires close monitoring and proactive action.

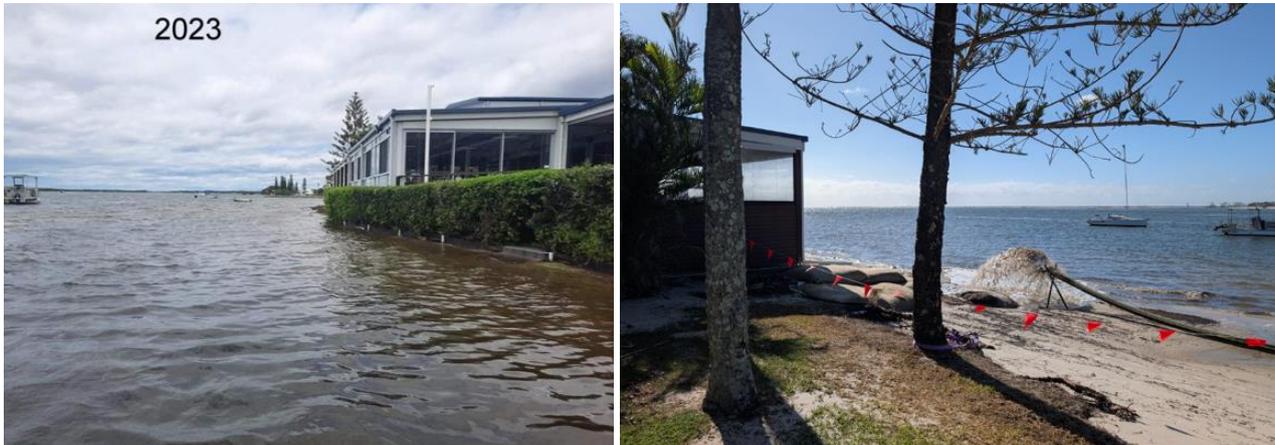
Figure 19: *Left:* Image from a boat during high tide in 2023, level unknown (PPCMB, 2023). *Right:* Sand nourishment in front of the Caloundra Power Boat Club on May 1, 2025 (RPS, 2025).

To support this, sand nourishment is being applied in front of the club to maintain a natural buffer, although it appears that this is not stabilising, requiring ongoing replenishment.

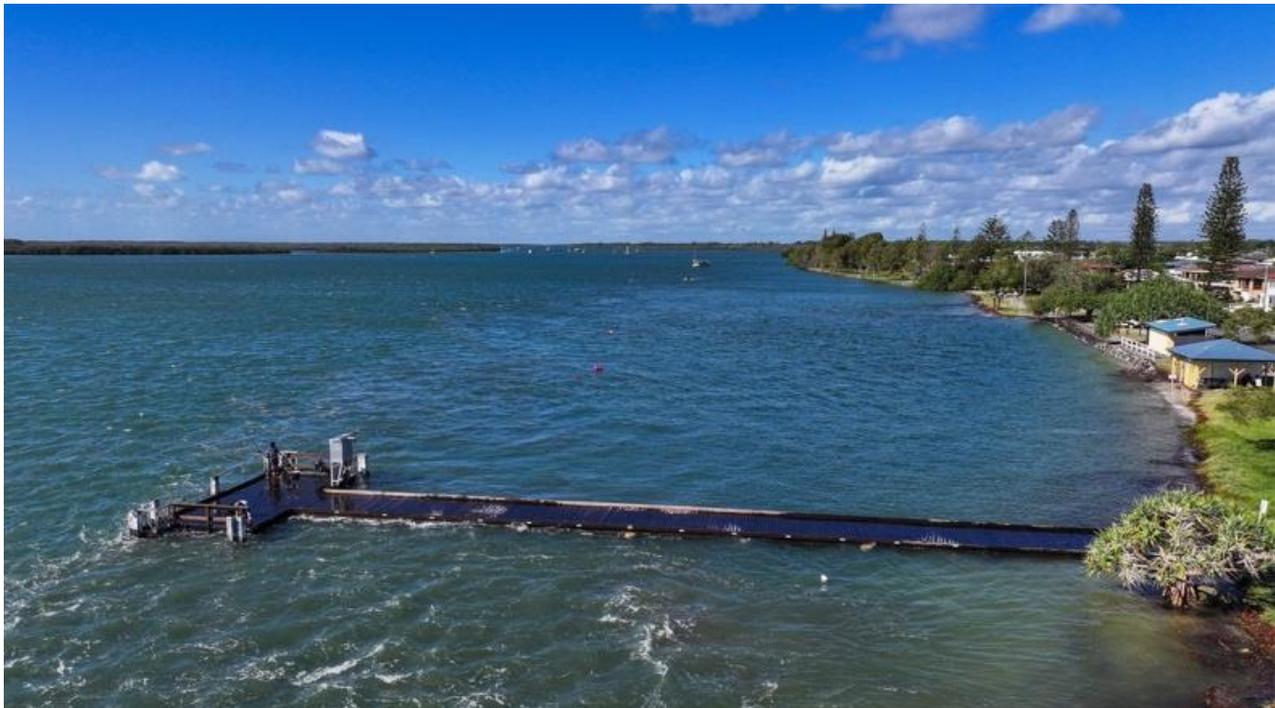
Figure 20: Image of the jetty on February 28, 2025 - high tide level reaching the top of the jetty pre-Tropical Cyclone Alfred (Bluey's Photography Facebook Account, 2025).

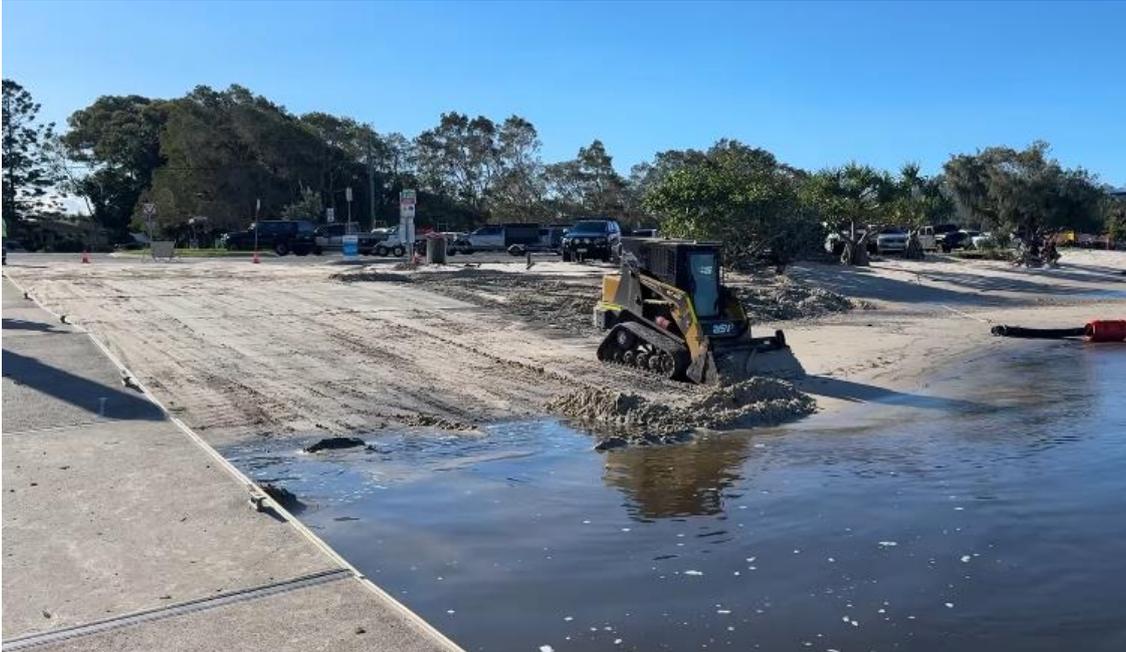
Figure 21: Image of the boat ramp with sand washing up along the shoreline and covering boat ramp access on April 29, 2025 (Caloundra Fishing World Facebook, 2025)

As wave energy moves towards the land, sand is physically pushed ashore, forming a new foreshore. This process, driven by increased wave exposure due to the breakthrough, has led to the redistribution of sediment in the affected areas.

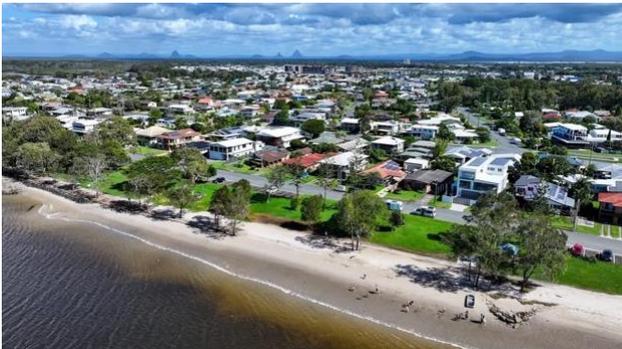
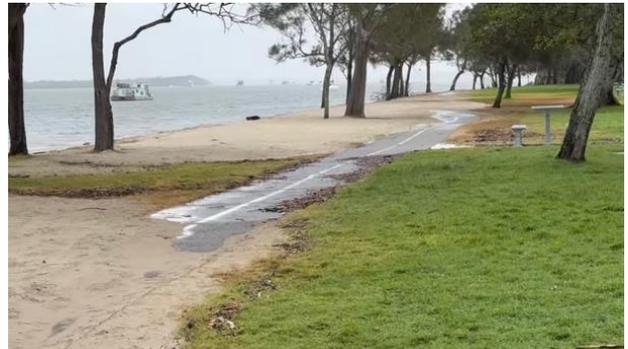
Figure 22: *Left:* Image taken on May 7, 2025, along inside of the second breakthrough, showing beach formation on diamond head (Bluey's Photography Facebook Account, 2025). *Right:* Sand washing over the foot path (PPCMB, 2025).

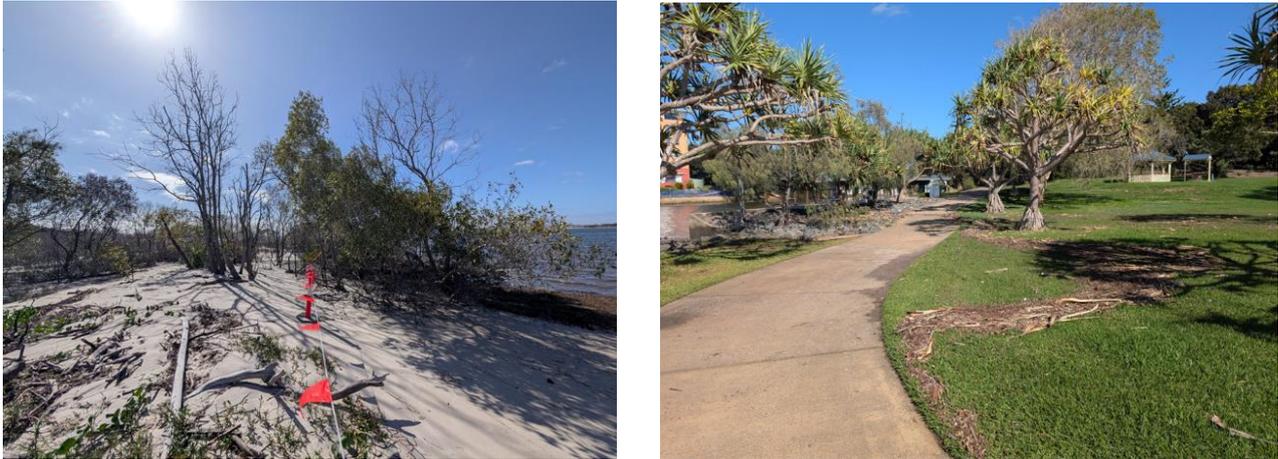
Figure 23: *Left:* Sand washing into mangrove ecosystem north of the Caloundra Power Boat Club. *Right:* Debris washed over the footpath during high tide, south of the Caloundra Power Boat club (Bluey's Photography Facebook Account, 2025).

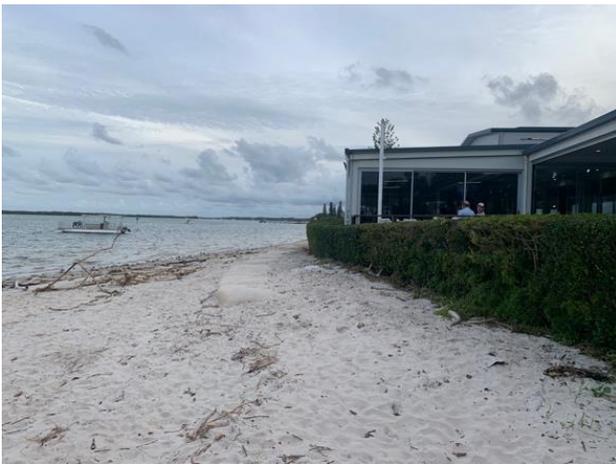
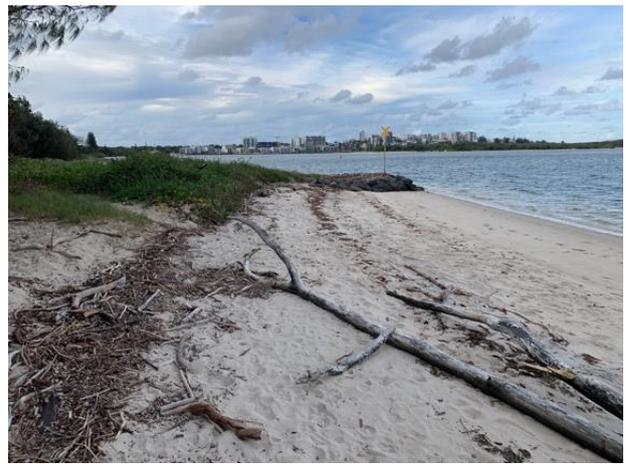
Figure 25: ICM site visit on March 24, 2025 (two weeks after Tropical Cyclone Alfred).

- Increased Breakthrough (widening of Breakthrough #1)
- Formation of a second Breakthrough (Breakthrough #2)
- Damage to and loss of public infrastructure on the island (e.g., Lions Park)
- Minor overtopping at Golden Beach and near the Caloundra Power Boat Club
- Minor overtopping at Diamond Head

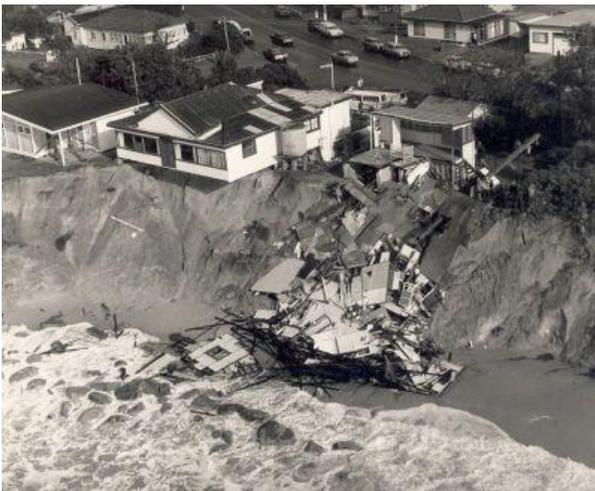
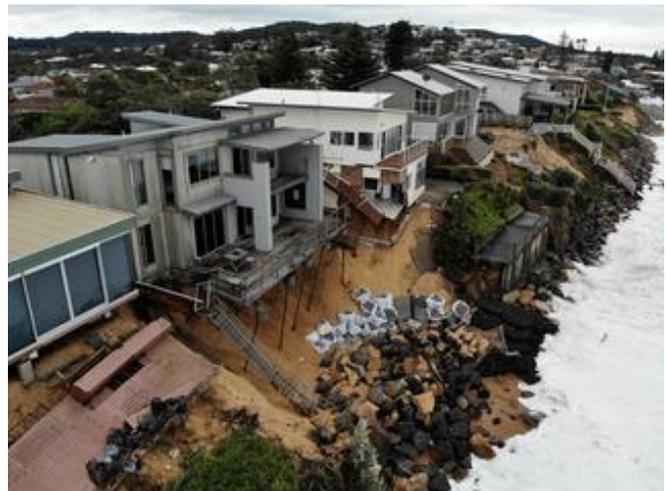
Figure 26: *Left: Wamberal 1978 erosion (Wamberal Net, 2025). Right: Wamberal 2025 beach erosion (Daily Telegraph, 2025).*

The do-nothing approach has been a common stance in many parts of New South Wales, where the default position often leaves communities and assets at the mercy of coastal change. A clear example of this can be seen at Wamberal, where homes were severely threatened by erosion as early as 1978. Fast forward to 2025, and similar images still emerge, with properties and infrastructure again facing collapse. These repeated events highlight the reality that while natural systems are dynamic, the risks from doing nothing are compounding. Erosion is not just a one-off event; it is persistent and worsening due to a combination of natural variability and human influence. Without action, damage continues, uncertainty grows, and opportunities for proactive, managed outcomes are lost.

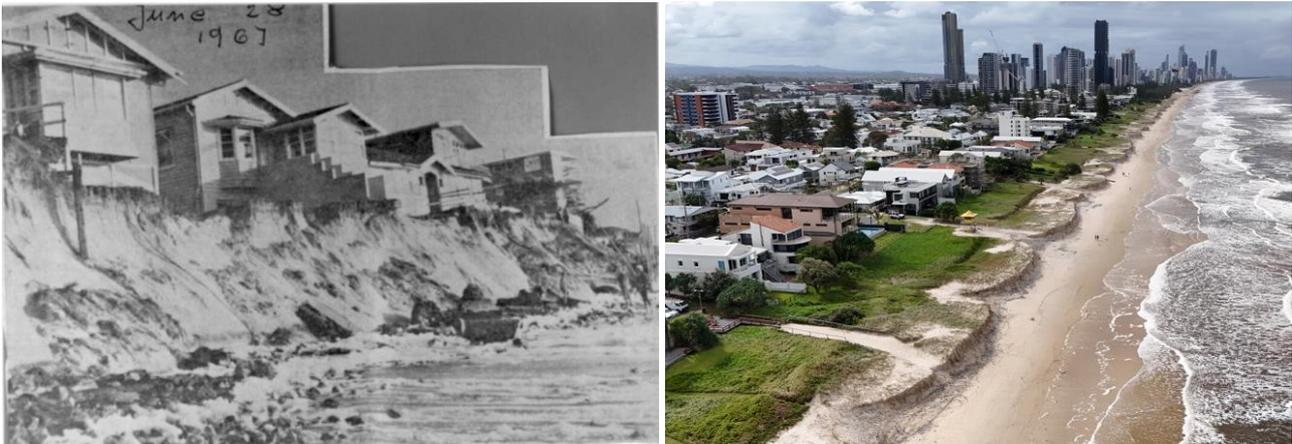
Figure 27: *Left: Gold Coast Cyclone 1967 (ICM Archives). Right: Gold Coast April 2025, post Tropical Cyclone Alfred (ICM, 2025).*

Tourism returned almost immediately, emphasising the success of decades of proactive investment in coastal management. Key to this success was the implementation of pilot projects, the trialling of innovative solutions, and continuous monitoring and adaptation. Many of these pioneering strategies, now globally recognised, were initiated by Angus Jackson, founder of International Coastal Management (ICM), during his tenure as Head of the Coastal and Waterways Department at Gold Coast City Council in the 1970s and 80s. This approach shows that with vision, leadership, and a willingness to learn, coastlines can be not only

protected but enhanced for future generations. It is noted that the Gold Coast is not a ‘perfect’ solution, yet it highlights the nature of taking action, monitoring, learning, adapting and progressing in the coastal resilience approach.

It should be noted the Sunshine Coast has also been proactive in coastal management practices in many locations over the years and therefore has a precedent for acting. The above-mentioned Gold Coast example is for reference only as it is relevant to the latest impacts of Tropical Cyclone Alfred (of which this report has been triggered by). It is not the intent of the design approach to re-create the Gold Coast, only the proactive management approach using innovative solutions.

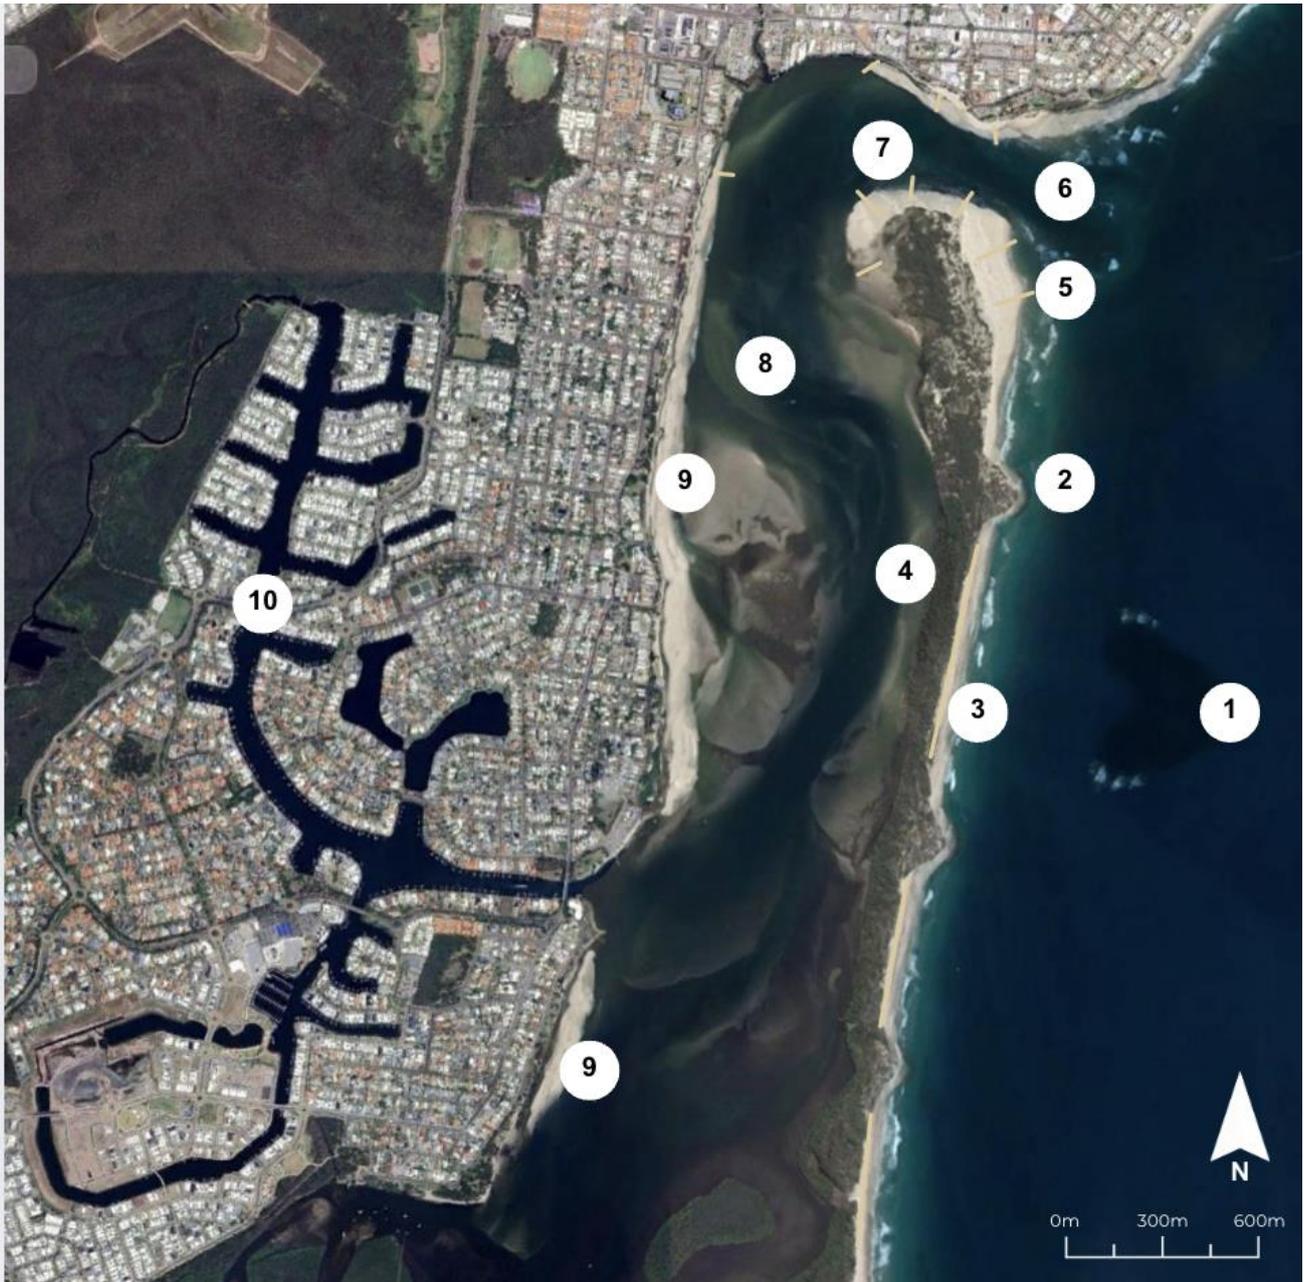
Figure 28 Potential future options using different elements from the ‘toolkit’ (ICM, 2025).

8	Shifting main channel (offset from Golden Beach)	Re-aligning the main channel further offshore from Golden Beach would reduce direct tidal and wave energy on the mainland foreshore, allowing for natural beach widening and the creation of a broader dune buffer.
9	Increase sand and dune buffer along Golden Beach	This approach enhances the resilience of beachfronts by enabling space for dune restoration, reducing erosion pressure, and improving long-term coastal stability. It also provides greater flexibility for future adaptation and protection strategies along the urban interface. It may be done in conjunction with plans to build seawalls along this shoreline which could be buried.
10	Weir Improvement/Upgrades	Enhancing the capacity of the existing weir system may help manage the increased tidal ranges observed since the breakthrough events. By better regulating water flow and levels, this option could support improved water quality, flood resilience, and system-wide hydrodynamic balance. Note: this element has been flagged for consideration going forward and is not a design recommendation.

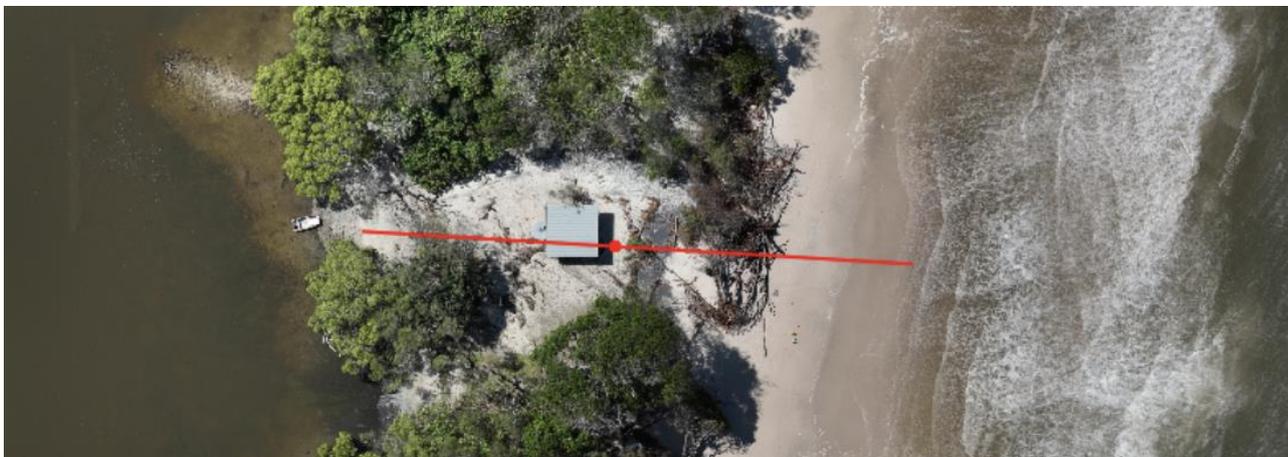
Figure 30: Survey transect (post TC Alfred) - near Breakthrough #2 (Drone Survey by Elysia Andrews, Queensland Government Hydraulics Laboratory)

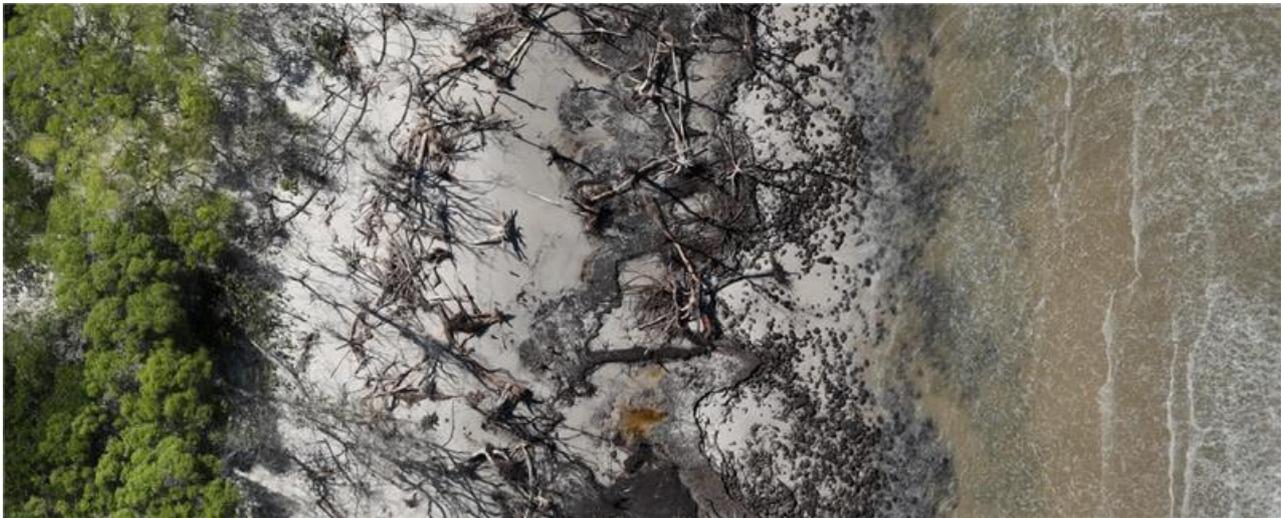
Figure 35: Aerial image of debris, vegetation and potential peat/coffee rock along 'edge' of existing island (Drone Survey by Elysia Andrews, Queensland Government Hydraulics Laboratory).

Introducing protective measures in front of the vegetation could help slow the degradation, retain the island's form for longer, and buy time for more comprehensive future planning.

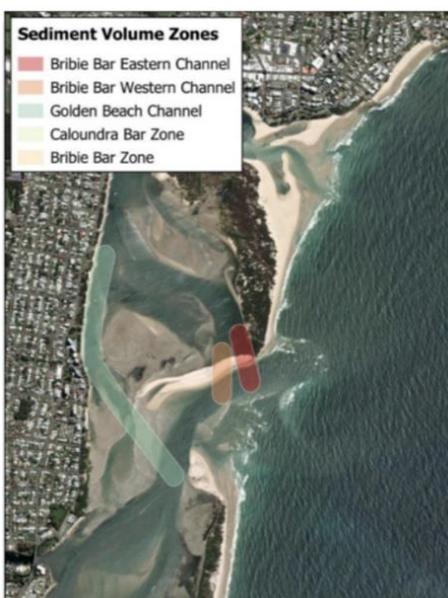
Figure 37: Aerial image of Bribie Island, indicating the three northern channel options previously considered by MSQ in a modelling investigation detailing the capital dredge volumes required and the predicted sedimentation rates (Waterhouse, A., 2023).

Improving flushing and access was considered in the Waterhouse (2023) report, which determined suitable (concept) channels, their respective dredge volume and assumed infill rates as per the following:
