4.4.1.2 Migratory species

4.4.1.3 Essential habitat

4.4.1.4 State and regional wildlife corridors

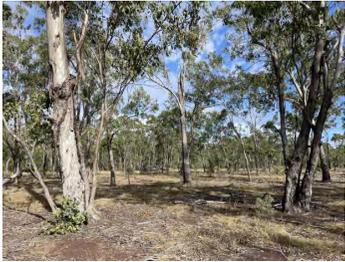
Habitat type	General characteristics and ecological values
<p>Mature eucalypt open woodland</p>

<ul style="list-style-type: none"> – Mature <i>Eucalyptus</i> species provides blossom and nesting opportunities for honeyeaters, flower peckers and parrots, and foraging habitat for flying-foxes. – Hollow-bearing trees are moderately dense, retaining small to medium sized hollows. Very few large hollows (> 30 cm) were observed. – Relatively complex ground-level microhabitats, with a high density of woody debris and leaf litter, and some ground logs. These microhabitats provide shelter and foraging microhabitat for ground-dwelling mammals, reptiles and amphibians. – Sparse, low ground cover, dominated by native grasses. Grasses provided food resources for some granivorous birds and herbivorous mammals. <p>MNES and MSES species:</p> <ul style="list-style-type: none"> – Potential foraging habitat for the squatter pigeon (southern) within 1 km (for breeding) and 3 km (for foraging) of a suitable, permanent or seasonal waterbody. – Potential foraging and denning habitat for the greater glider (southern and central) and yellow-bellied glider (south-eastern). – Potential foraging habitat for the powerful owl, koala and grey-headed flying-fox. – Potential foraging and breeding habitat for the ornamental snake (only woodland habitats retaining <i>Eucalyptus coolabah</i>).

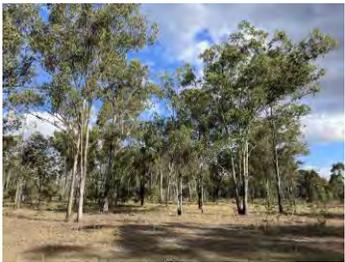
<p>Mixed <i>Eucalyptus/Corymbia</i> open woodland</p>

<ul style="list-style-type: none"> – Eucalypts provide blossoms and nesting opportunities for honeyeaters, and foraging habitat for flying-foxes. – Variety of koala food trees present, including <i>Eucalyptus tereticornis</i>, <i>E. crebra</i>, <i>E. coolabah</i>, <i>E. moluccana</i>, <i>E. exserta</i>, <i>Corymbia tessellaris</i>, <i>C. citriodora</i>, <i>C. erythrophloia</i>, <i>C. intermedia</i> and <i>Lophostemon suaveolens</i>. – Low density of hollow-bearing trees present. Hollows are relatively small, providing suitable habitat for hollow-nesting birds (i.e. parrots and lorikeets), small mammals (i.e. gliders) and arboreal reptiles and amphibians. – Ground-level microhabitats varied throughout vegetated areas. Moderately dense to sparse ground logs, woody debris, rocks and leaf litter were present, providing shelter and foraging habitat for small to medium sized mammals, reptiles and amphibians. – Decorticated bark provide refuge for microbats, reptiles and amphibians. – Groundcover densities varied throughout vegetated areas. A mixture of native and introduced grasses were present. <p>MNES and MSES species:</p> <ul style="list-style-type: none"> – Potential foraging habitat for the squatter pigeon (southern) within 1 km (for breeding) and 3 km (for foraging) of a suitable, permanent or seasonal waterbody. – Potential foraging habitat for the greater glider (southern and central) and yellow-bellied glider (south-eastern). – Potential foraging habitat for the koala and grey-headed flying-fox.

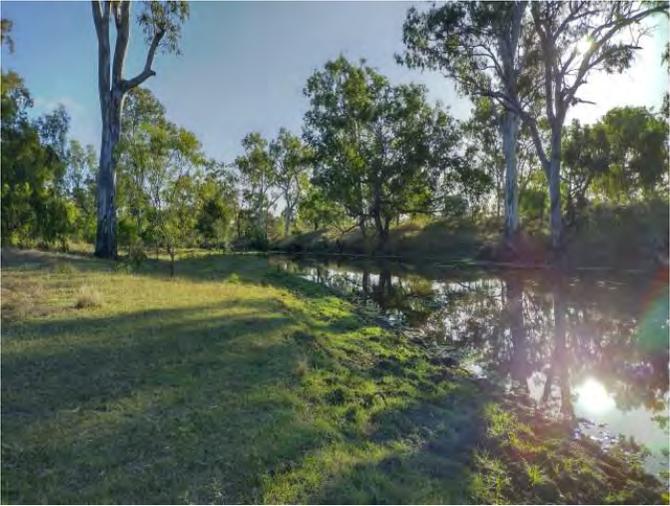
Site	Characteristics	Ecological values
Site 6 – Gavial Creek		
Upstream	<ul style="list-style-type: none"> – Purple – major risk waterway mapped under the WWBW spatial layer. – Gavial Creek at site 6 has a meandering channel with a wetted with of 10 m and a depth >2 m. – There was no Water flow at the time of the survey and was below the watermark. – Water clarity was turbid. – Land use adjacent to the survey area on both banks were subject to cattle grazing. – The was a moderate amount of erosion present and with a loosely compacted bed substrate that consisted of 100% silt/clay. – Both banks had a low slope and were 5 m high and with a moderate level of erosion. – Riparian vegetation was regularly spaced on both banks with a moderate amount of <i>Eucalyptus</i> trees <10 m and >10m high providing the site with 25% shading and 15% trailing bank vegetation 	<ul style="list-style-type: none"> – Overall habitat condition rating was fair (64). – Instream habitat consisted of deep pools, with some submerged and some floating aquatic macrophytes. – There were some log jams and woody debris present within the waterbody. – Gavial Creek at this location provides suitable habitat for many fish and turtle species. – Provides optimal habitat and burrowing opportunities for the platypus, and the species is likely to occur at this site. – Site is sub-optimal foraging and marginal breeding habitat for the estuarine crocodile. The species may occur at this site

Downstream	<ul style="list-style-type: none"> – The riparian zone also contained a moderate amount of grasses, and some shrubs.

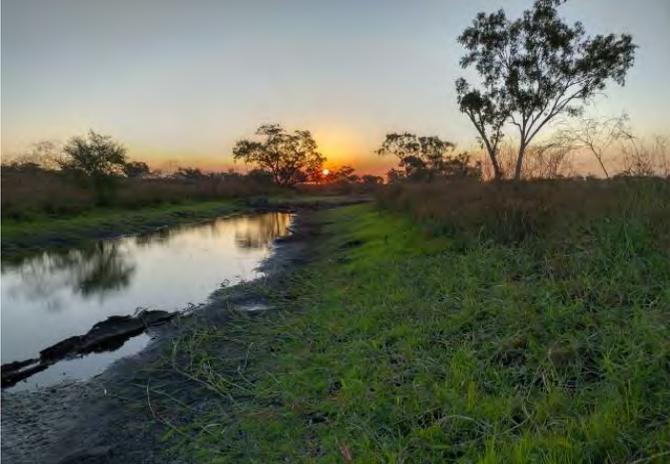
Site	Characteristics	Ecological values
Site 21 – Scrubby Creek		
Upstream

<ul style="list-style-type: none"> - Purple – major risk waterway mapped under the WWBW spatial layer. - Scrubby Creek at site 21 consisted of an irregularly meandering channel with wetted width of 4 m. - Water was present in an isolated pool that was 0.3 m deep. - Land adjacent to the survey area on both banks cleared for cattle grazing. - Bed substrate was stable, with a loosely compacted substrate. - Bed substrate comprised of 100% silt/clay. - Both banks had a low slope and a concave shape. Both banks were 0.5 m in height. - There was some local catchment erosion present and high level of bank stability. - There was a semi-continuous riparian zone along both banks that contained a moderate amount of grasses and shrubs, and some trees >10 m and <10 m in height. A moderate amount of the species present were exotic. - Shading was 5% and trailing bank vegetation 10%. 	<ul style="list-style-type: none"> - Overall habitat condition rating was poor (15). - Instream habitat consisted of pool/run habitat containing some small woody debris, - This location would provide optimal habitat for many fish species during wet periods. - Site not suitable for platypus refuge or borrowing opportunities.
