# Non-Indigenous Heritage Technical Report

CALVERT TO KAGARU ENVIRONMENTAL IMPACT STATEMENT

# **Inland Rail Calvert to Kagaru EIS**

Appendix T – Non-Indigenous  
Heritage Technical Report

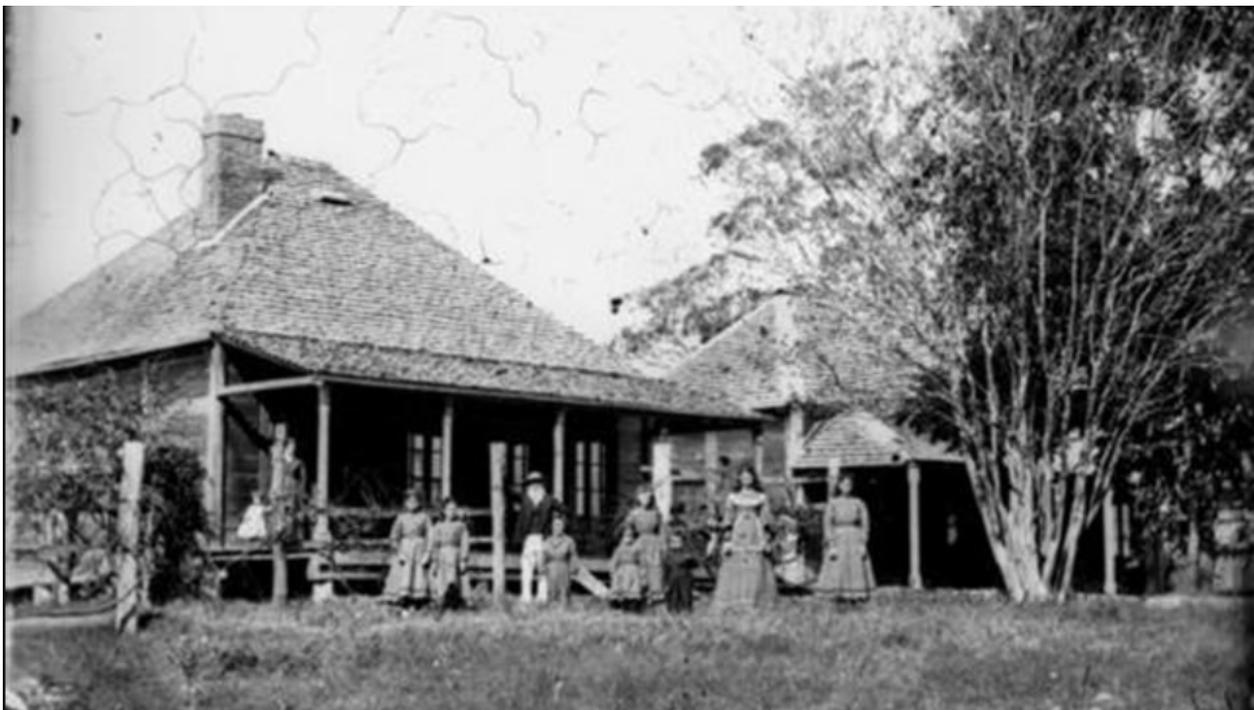
Figure 4.3 Bromelton House c1872 (SLQ 134937)

The Bromelton Run was established at the far eastern end of the cultural heritage study area in 1844. Initially taken up by Thomas Murray-Prior, it soon passed into the hands of the McDonalds, who built a fine house for themselves on the banks of Bromelton (or Bungoroopin) Lagoon (refer Figure 4.1 and Figure 4.3). The McDonalds raised their 14 children on the property, as well as several orphaned nieces and nephews from the nearby Undullah Run (refer Section 4.2.2) (Collyer 1991; Gray-Woods 1990).

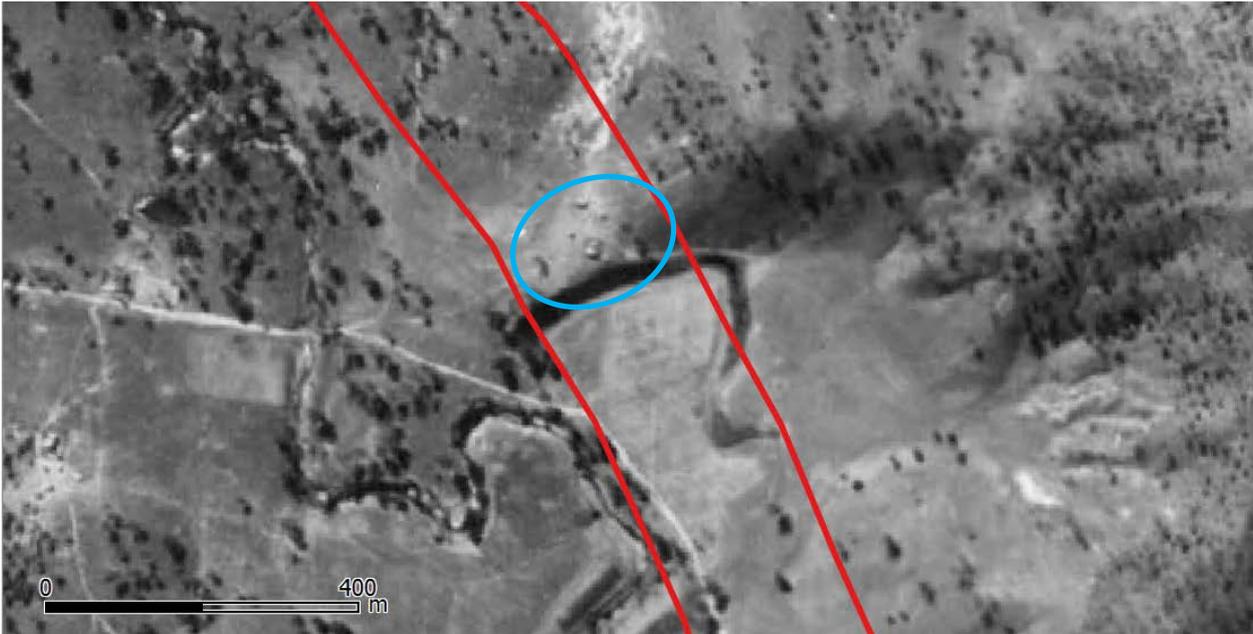
**Figure 4.7** Detail of 1944 aerial showing Washpool, structures (blue) and cultural heritage study area (red) (MAP1539489)

It is unclear for how long Lang's gin was in operation, or what use it may have been subsequently put to, but buildings are evident at the Washpool site both in the 1920s topographic maps, and the 1944 aerial photographs (refer Figure 4.7 and Figure 4.8).

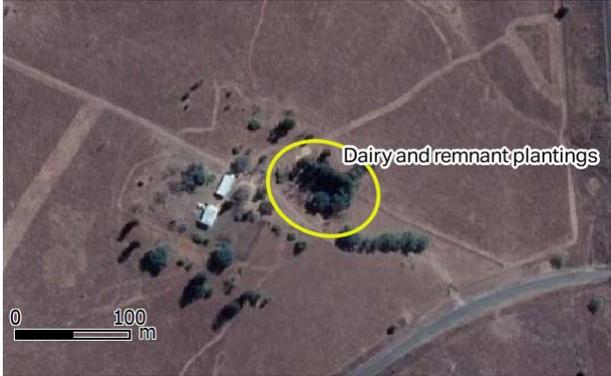
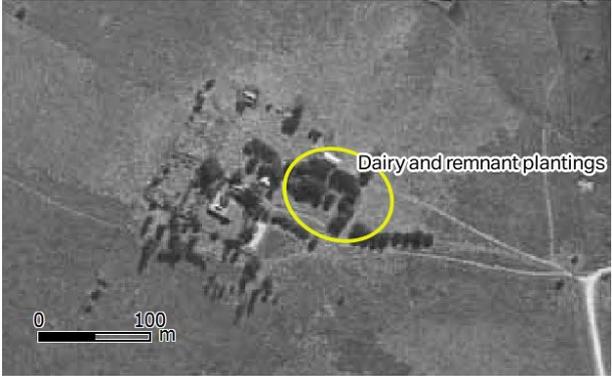
Table 6.2 Inspection results – Brooklands Homestead (C2K-19-H1)

Description		
<p>The site of Brooklands established in 1898 (refer Section 4.2.1). Located on a rise on Lot 1/RP180942, 700 m east of Teviot Brook. The original homestead was demolished in mid-20<sup>th</sup> century, but other original elements remain, including garden plantings and a ruined dairy.</p>		
Current imagery	Historical imagery (1959 QAP0890113)

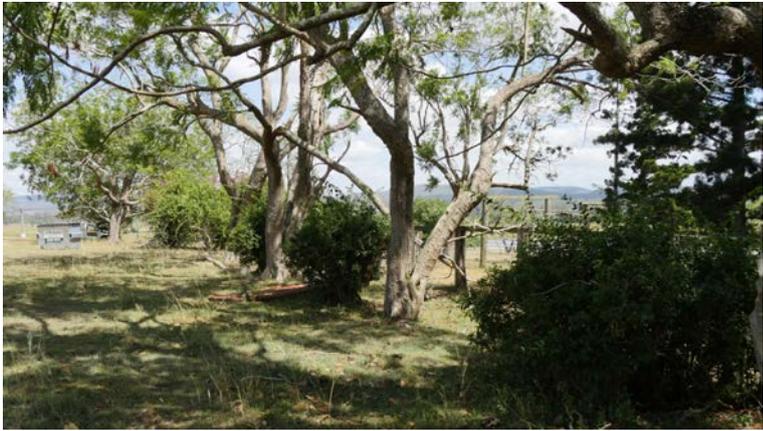
<p>Photograph 6.1 C2K-19-H1 plantings</p>

Key elements		
Remnant plantings	Easting (GDA94 Z56)	Northing (GDA94 Z56)
<p>Remnant garden plantings – a row of six mature bougainvillea bushes (<i>Bougainvillea sp.</i>) interspersed with later jacaranda trees (<i>Jacaranda mimosifolia</i>) along the drive (Photograph 6.1). A row of hoop pine (<i>Araucaria cunninghamii</i>) has been planted to the north. A new set of cattle yards has been constructed amongst the plantings.</p>	492159mE	6918052mN
	492173mE	6918056mN
	492204mE	6918032mN
	492207mE	6918035mN
	492195mE	6918040mN
	492187mE	6918029mN

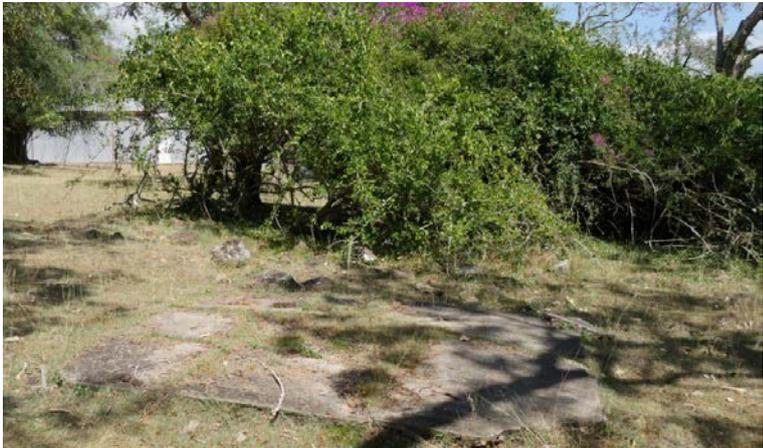
**Photograph 6.2 C2K-19-H1 concrete slab**

Concrete slab	Easting (GDA94 Z56)	Northing (GDA94 Z56)
Small concrete slab (approximately 2 m x 2 m) adjacent to large bougainvillea bush (Photograph 6.2). Current landholders believe this may have been part of the dairy, or else a small shed (Noel Cannon pers. comm., 15 January 2019).	492192mE	6918039mN

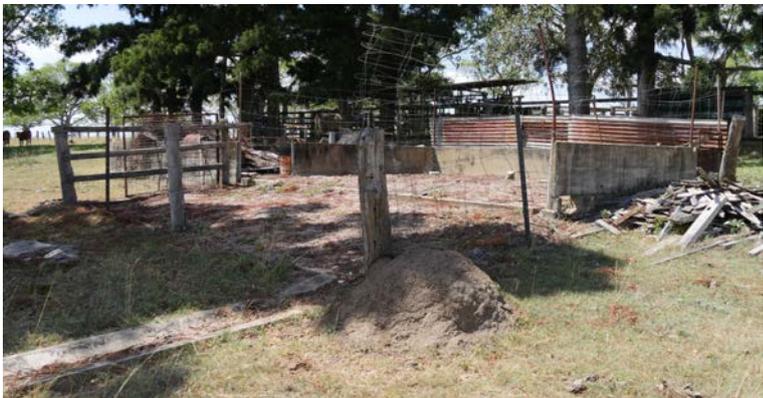
**Photograph 6.3 C2K-19-H1 dairy**

Dairy	Easting (GDA94 Z56)	Northing (GDA94 Z56)
Large concrete slab (approximately 12 m x 7 m) with low concrete walls forming two rooms (Photograph 6.3). A small fenced pen adjoins the larger of the two rooms, and a shallow concrete drain runs downhill from the northwest corner of pen. Believed to have been a dairy (Noel Cannon pers. comm., 15 January 2019), the structure is littered with a variety of building and farming refuse.	492192mE	6918039mN

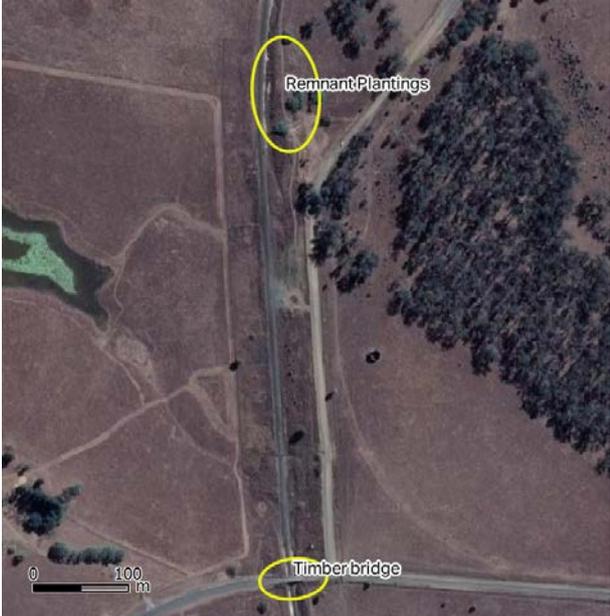
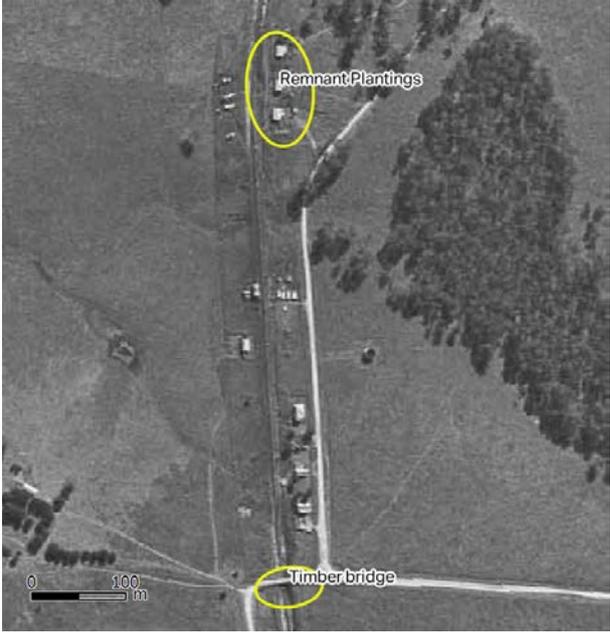
Table 6.3 Inspection results – Kagaru Station (C2K-19-H2)

Description		
<p>Location of former Kagaru Station, constructed c.1930 as a part of the Sydney to Brisbane Line (Section 4.2.1). Situated on Lot 232/SP130091, the site could not be inspected due to access and safety constraints, but a number of elements were noted from adjacent areas, including a timber road bridge, water standpipes and remnant plantings.</p>		
Current imagery	Historical imagery (1959 QAP0890113)

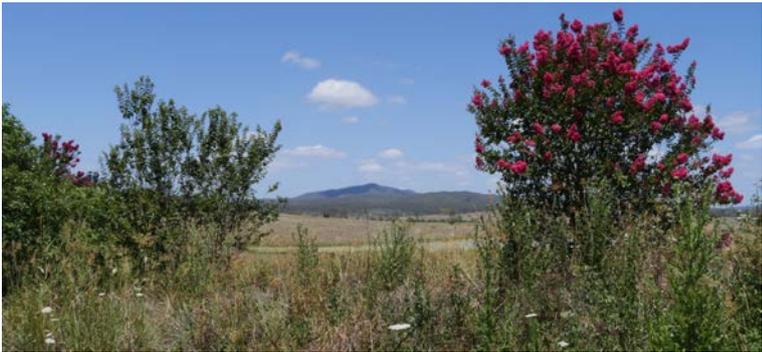
<p><b>Photograph 6.4</b> C2K-19-H2 plantings</p>

Key elements		
Remnant plantings	Easting (GDA94 Z56)	Northing (GDA94 Z56)
<p>Remnant garden plantings including crepe myrtle (<i>Lagerstroemia</i> sp.) and Brazilian peppertree (<i>Schinus terebinthifolius</i>) at the far northern extent of the site (Photograph 6.4). Historical aerials show what appear to be three houses in this location.</p>	492476mE	6918500mN
	492479mE	6918459mN
	492474mE	6918528mN
	492476mE	6918457mN
	492486mE	6918445mN
	492484mE	6918484mN

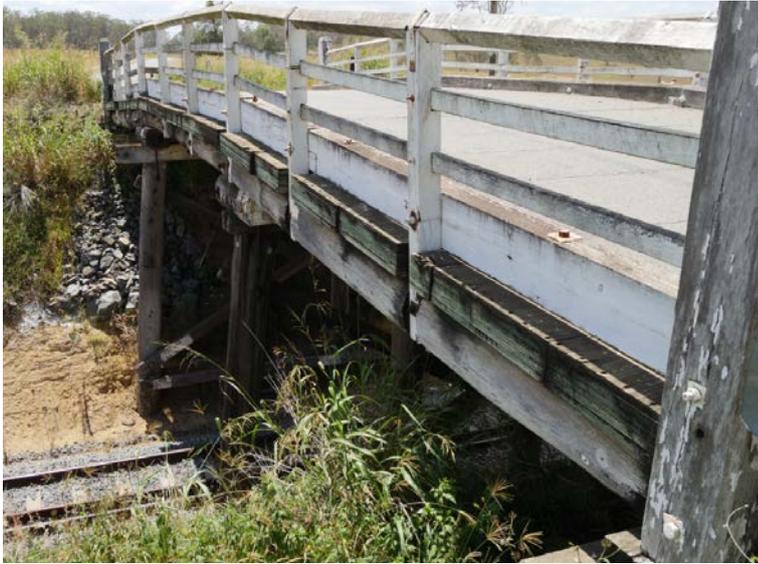
Photograph 6.5 C2K-19-H2 bridge

Timber bridge	Easting (GDA94 Z56)	Northing (GDA94 Z56)
<p>The bridge at the southern end of the Kagaru Station is part of Undullah Road, providing road access over the rail line, and appears to be a standard girder timber bridge as constructed in Queensland from 1925 onwards (Department of Main Roads 2005). The structure consists of driven timber piles surmounted by timber headstock, corbels and girders, and a plywood deck finished with bitumen (Photograph 6.5). The individual elements of the bridge are of various different ages – a result of the regular replacement of failing components – but the overall structure appears consistent with the original design.</p>	492449mE	6917994mN

D – representativeness	The timber road bridge at the southern extent of Kagaru Railway Station appears to be in good condition and is a good representative of its type.	<input type="checkbox"/> Not met <input checked="" type="checkbox"/> Local <input type="checkbox"/> State
E – aesthetic	Kagaru Station has no known aesthetic significance.	<input checked="" type="checkbox"/> Not met <input type="checkbox"/> Local <input type="checkbox"/> State
F – creative/technical	Kagaru Station does not contain any elements of known technical or creative merit.	<input checked="" type="checkbox"/> Not met <input type="checkbox"/> Local <input type="checkbox"/> State
G – social	Kagaru Station does not have any known social significance to any community.	<input checked="" type="checkbox"/> Not met <input type="checkbox"/> Local <input type="checkbox"/> State
H – associational	Kagaru Station does not have any known special association with person or group of people of historical importance.	<input checked="" type="checkbox"/> Not met <input type="checkbox"/> Local <input type="checkbox"/> State

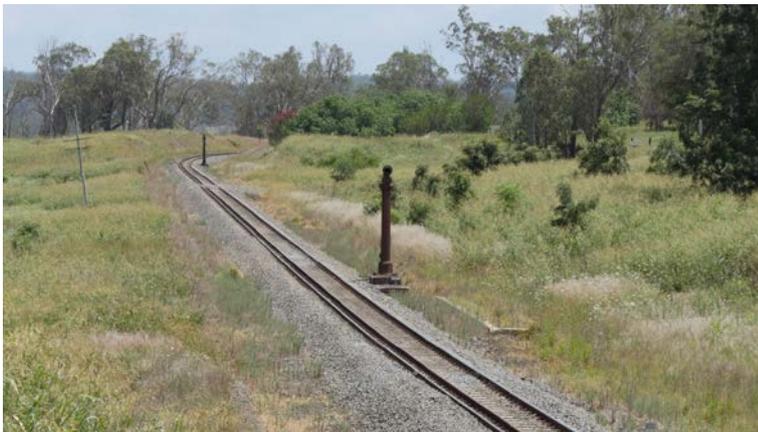
Photograph 6.6 C2K-19-H2 standpipes

Standpipes	Easting (GDA94 Z56)	Northing (GDA94 Z56)
<p>Much of the rail corridor was thickly grassed, making it difficult to identify what rail infrastructure may remain. However, two water standpipes were noted towards the middle of the former station area (Photograph 6.6). It is understood that these are linked to a large concrete tank on a hill 100m to the east (Noel Cannon pers. comm., 15 January 2019) and outside of the cultural heritage study area.</p>	492478mE	6918097mN
	492457mE	6918419mN

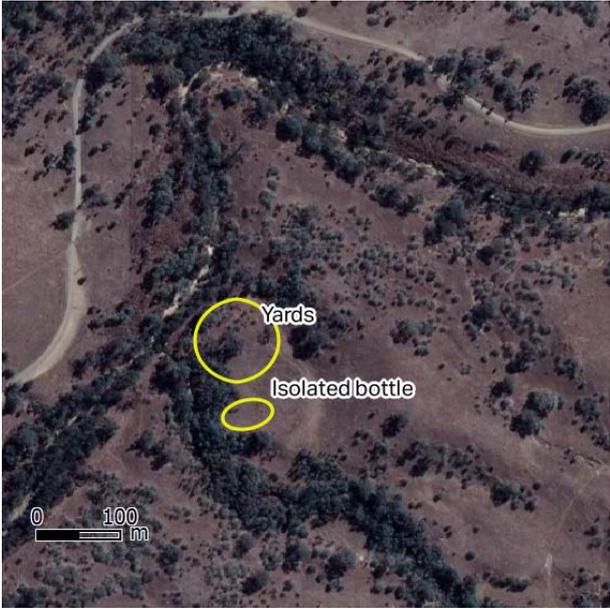
**Table 6.4 Inspection results – Kenny’s Hut (C2K-19-H3)**

Description		
<p>Location of site referred to as ‘Kenny’s Hut’ on a 1927 topographic map (Australian Section Imperial General Staff 1927) (refer Section 4.2.2). Discussions with nearby landholders suggest that the site continues to be known by this name to the present day (Noel Cannon pers. comm., 15 January 2019).</p> <p>The site of Kenny’s Hut is located on a low-lying creek flat on the eastern side of Woollaman Creek on Lot 22/RP908750. The area is bounded to the south by an unnamed tributary of Woollaman Creek and to the north and east by a wide, shallow gully that curves around the site. This gully likely forms a lagoon during the wet season, turning Kenny’s Hut site into a small island.</p> <p>No evidence of a dwelling was found at this location, but a well-built set of yards was identified, along with an isolated bottle that may mark the former hut site.</p>		
Current imagery	Historical imagery (1944 MAP1539510)

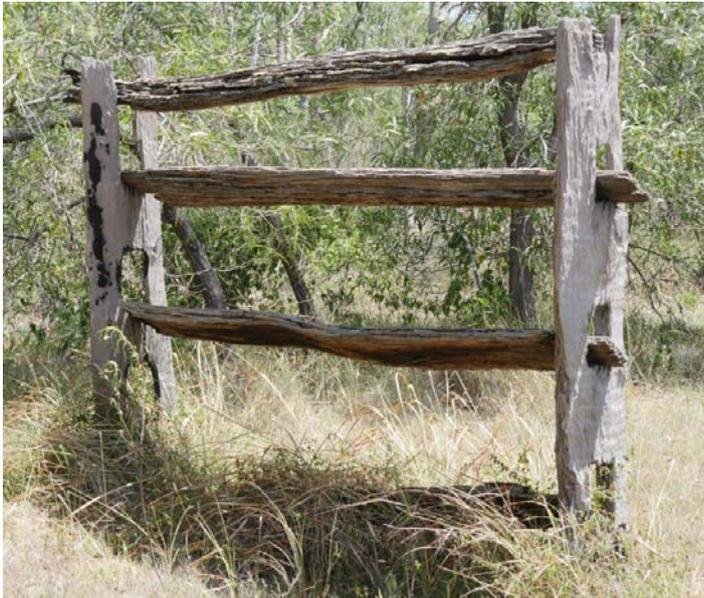
**Photograph 6.7 C2K-19-H3 post and rail fencing**

Key elements		
Yards	Easting (GDA94 Z56)	Northing (GDA94 Z56)
<p>The yards were partly overgrown with dense lantana, but at least 9 posts could be identified, forming a circle of approximately 45 m in diameter. The posts are all of unmilled bush timber, around 2 m tall and spaced 3 m apart. Each of the posts is morticed to hold four bush timber rails, the ends of which are tenoned to fit into the posts.</p> <p>Such construction methods were in use in Australia from at least 1789, and are typical of yards, which required a sturdier barrier than the two-rail fences that generally sufficed for paddocks (Pickard 1998, 2005, 2009). However, these fences are time and resource intensive and, from the 1850s, were gradually replaced with wire and metal alternatives, before becoming obsolete in the first decades of the 20<sup>th</sup> century.</p>	485820mE	6917965mN
	485854mE	6917959mN
	485823mE	6917959mN

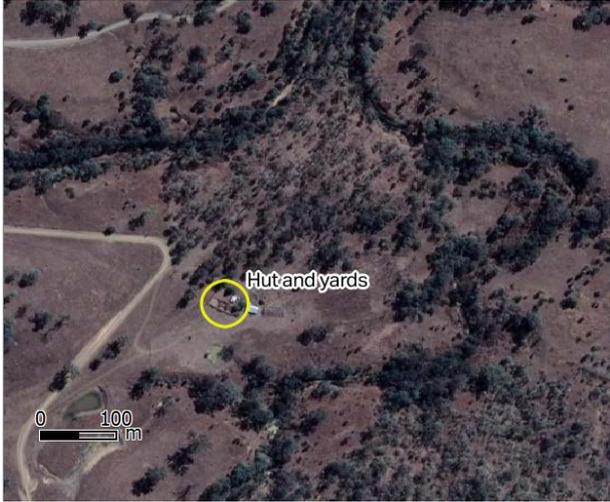
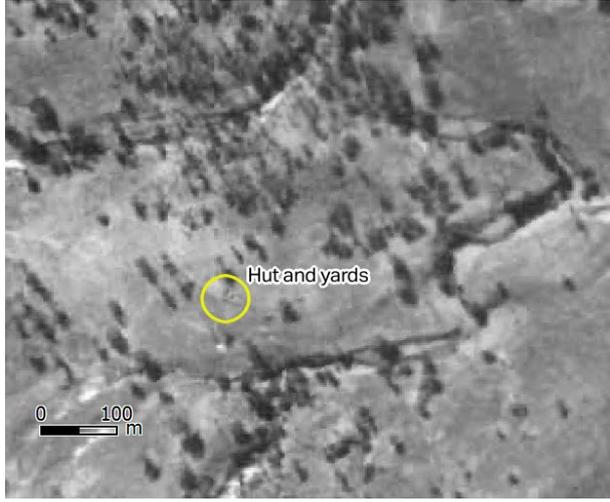
**Table 6.5 Inspection results – Hut and yards (C2K-19-H4)**

Description		
<p>Location of site referred to as a 'Stock Yard' on a 1927 topographic map (Australian Section Imperial General Staff 1927) and as a 'Slab Hut' (Site 48) in the previous Jacobs report (Jacobs Group (Australia) Pty Limited 2016).</p> <p>The site is located on a creek flat approximately 200 m south of the confluence of Wild Pig Creek and Woollaman Creek on Lot 1/SP163227, and consists of a small hut, built partially of timber slabs, and a dilapidated set of yards. To the east of this complex is a 20<sup>th</sup> century metal clad shed.</p>		
Current imagery	Historical imagery (1944 MAP1539510)

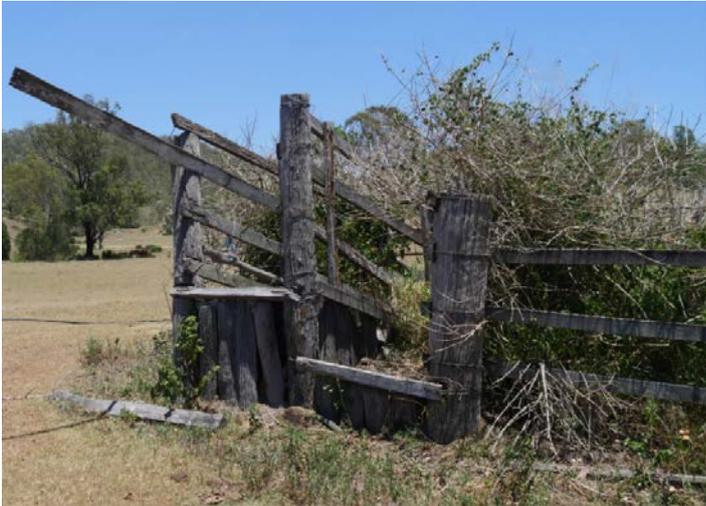
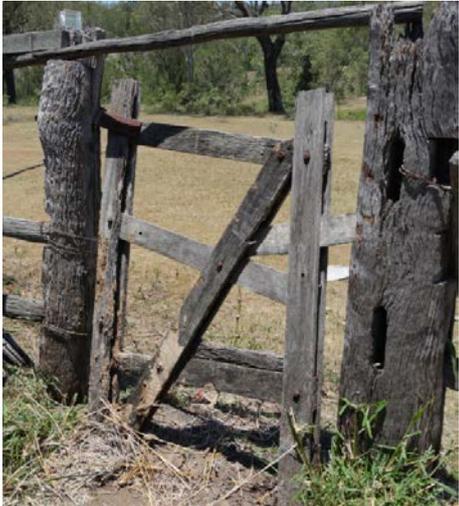
<p><b>Photograph 6.11 C2K-19-H4 yards and ramp</b></p>	<p><b>Photograph 6.12 C2K-19-H4 yards</b></p>

Key elements		
Yards	Easting (GDA94 Z56)	Northing (GDA94 Z56)
<p>The yards are rectangular, measuring approximately 20 m x 30 m with a ramp in the south east corner. The original construction appears to have been bush timber post and four rails, suggesting an establishment date in the early 20<sup>th</sup> century (Pickard 1998, 2005, 2009), but none of the tenoned rails remain, replaced instead by milled timber wired onto the posts.</p>	484902mE	6917194mN

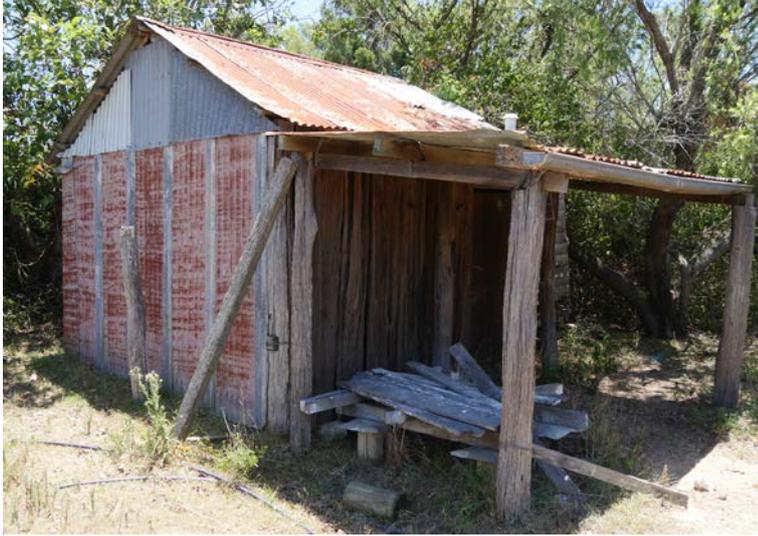
Photograph 6.13 C2K-19-H4 hut exterior

Hut	Easting (GDA94 Z56)	Northing (GDA94 Z56)
<p>The hut is a small structure, measuring approximately 5 m x 6 m, and features a corrugated iron gable roof. In front of the building is a lean-to with a corrugated iron skillion roof that forms a small verandah.</p> <p>The front wall of the structure is of bush timber slabs, but the remainder is a standard timber frame constructed from a mixture of milled and unmilled timber, and clad in corrugated iron.</p>	484935mE	6917180mN

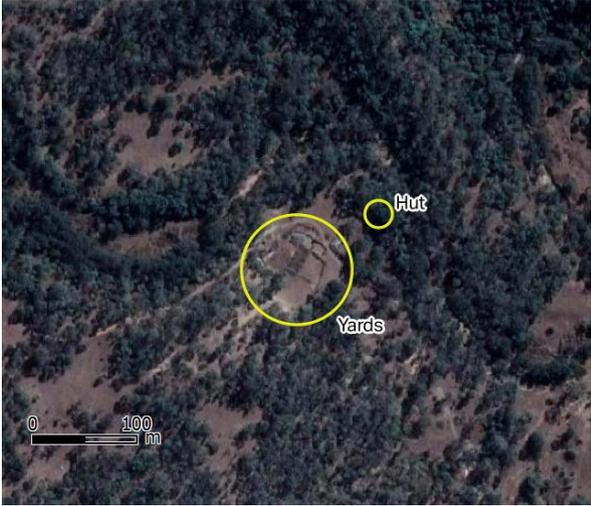
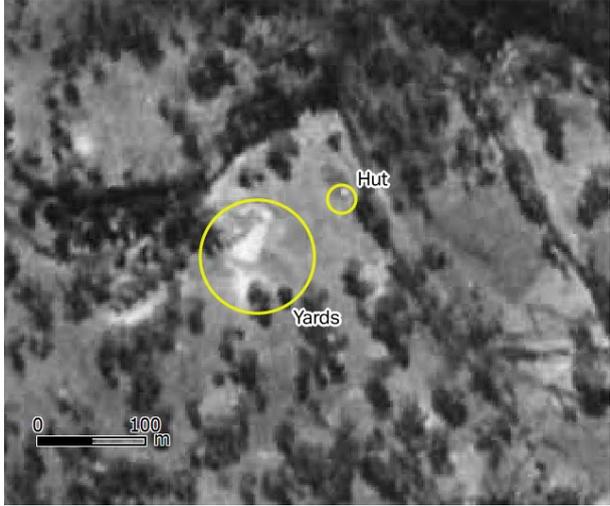
**Table 6.6 Inspection results – O’Neill’s Hut (C2K-19-H5)**

Description		
<p>Location of a site referred to as ‘O’Neill’s Hut’ on a 1927 topographic map (refer Section 4.2.2) (Australian Section Imperial General Staff 1927). Discussions with nearby landholders indicate that the site operated as a cattle yard until the late 20<sup>th</sup> century, during which time it was used by a number of local families to cooperatively muster stock (Noel Cannon pers. comm., 15 January 2019).</p> <p>The site is located on a creek flat on the southern side of Dugandan Creek. It is part of Lot 259/RP809310 and is bisected by the gazetted but unconstructed Wild Pig Creek Road. The site includes a corrugated iron clad hut and a sprawling set of yards and cattle dip. The area is littered with a variety of modern refuse, and it is possible that the remnants of other structures are located in the dense lantana that surrounds the site.</p>		
Current imagery	Historical imagery (1944 MAP1539513)

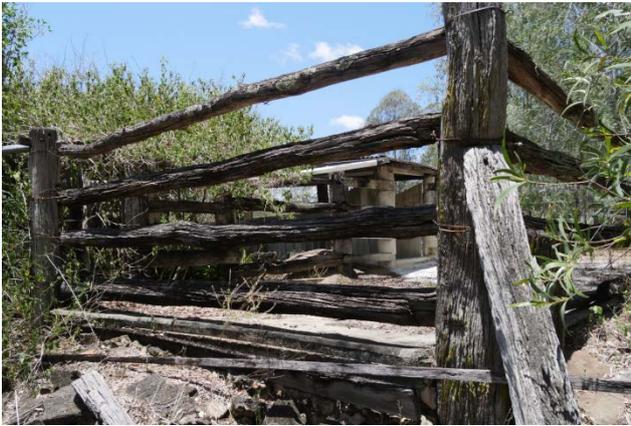
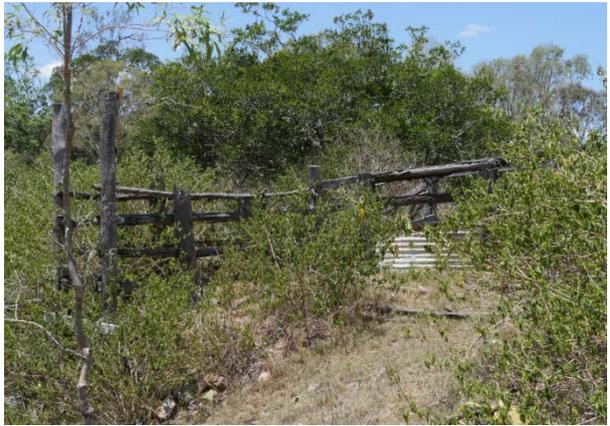
Photograph 6.16 C2K-19-H5 dip	Photograph 6.17 C2K-19-H5 yards and ramp

Key elements		
Yards	Easting (GDA94 Z56)	Northing (GDA94 Z56)
<p>The yards are large and roughly rectangular, measuring approximately 75 m x 45 m, with a dip located in the south west corner (Photograph 6.16). The complex has been constructed over a long period, using a variety of materials including bush timber, milled timber, metal, and concrete (Photograph 6.17). There is no evidence of the rail and post construction seen at C2K-19-H4 and C2K-19-H3, suggesting that the extant yards are from a later period, perhaps the mid-20th century (Pickard 2005).</p>	482479mE	6917701mN
	482508mE	6917676mN
	482487mE	6917618mN
	482443mE	6917666mN

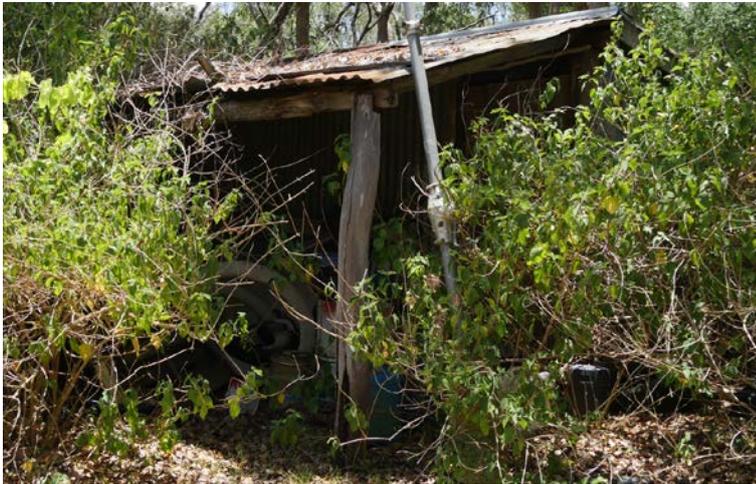
Photograph 6.18 C2K-19-H5 hut

Hut	Easting (GDA94 Z56)	Northing (GDA94 Z56)
Inspection of the hut was hampered by refuse and dense vegetation, but the structure appears to be very small, approximately 4 m x 4 m, half of which is open verandah. Visible timber elements were unmilled, and the whole structure was clad in corrugated iron (Photograph 6.18).	482556mE	6917710mN

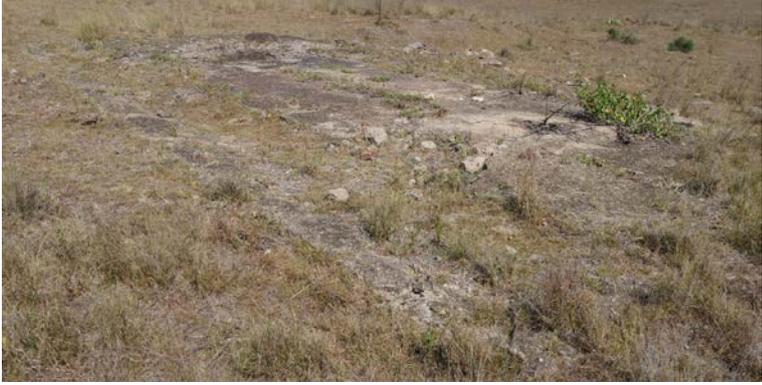
Key elements		
Dairy	Easting (GDA94 Z56)	Northing (GDA94 Z56)
<p>The dairy site consists of an approximately 10 m x 5 m concrete slab (Photograph 6.19). A shallow drain has been formed in the northern side of the slab, and there are remnants of reinforced concrete blocks, likely used to mount equipment.</p>	476468mE	6922125mN

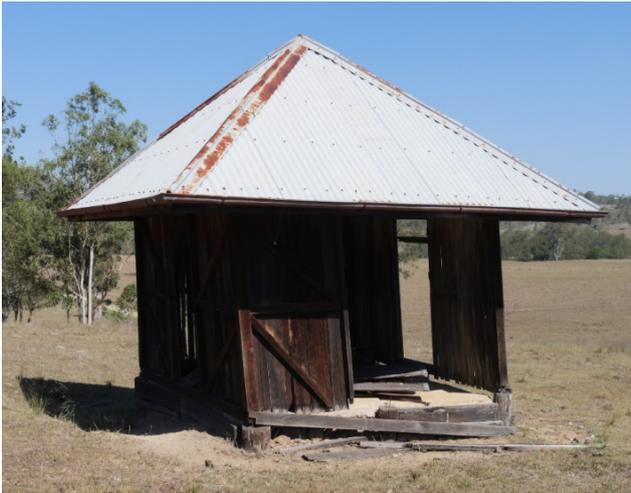
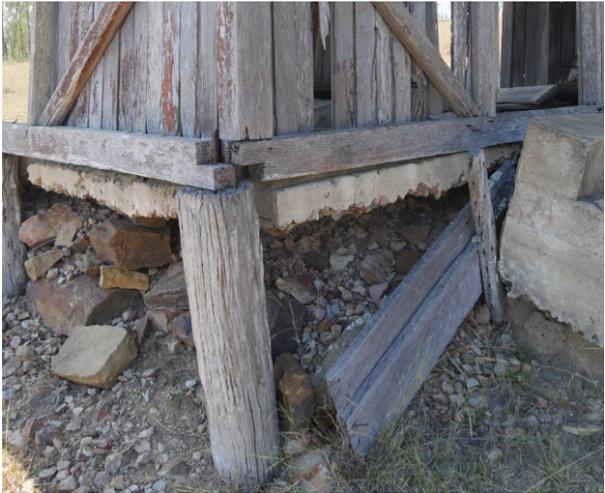
<p><b>Photograph 6.20 C2K-19-H6 creamery</b></p>	<p><b>Photograph 6.21 C2K-19-H6 creamery subfloor</b></p>

<p><b>Photograph 6.19 C2K-19-H6 dairy</b></p>		
Creamery	Easting (GDA94 Z56)	Northing (GDA94 Z56)
<p>The creamery is a small, square structure, measuring approximately 5 m x 5 m with a corrugated iron hipped roof (Photograph 6.20, Photograph 6.21, Photograph 6.22). The building rests on timber stumps and, at some point, the sub-floor has been filled with rubble and a concrete slab laid. The frame is of milled timber, as are the walls, which feature tongue and groove interior cladding and exposed exterior stud work. As is usual for a creamery, the interior cladding does not extend the full height of the wall, leaving a gap at the top to improve ventilation. A later ceiling has been installed, possibly using asbestos-bearing materials.</p> <p>The bowl of a milk separator was noted in the corner of the building (Photograph 6.23). The rounded, kettle-like shape of the bowl is consistent with separators manufactured after 1913 (Arnold 1999)</p>	476477mE	6922139mN

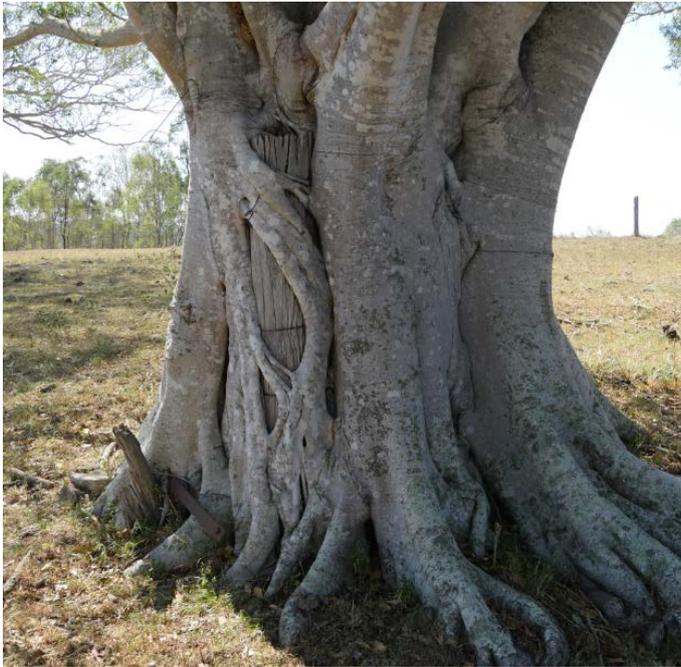
Photograph 6.25 C2K-19-H6 fence post

Three fence posts were noted 50 m north of the creamery, all of which had been colonised by a species of strangler fig (*Ficus sp.*). The size of the figs suggests that the fence posts had been in place for some time, and were likely contemporaneous with the dairy and creamery.

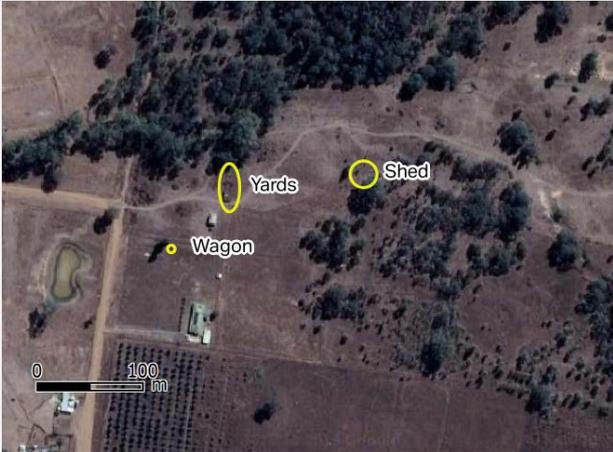
**Table 6.9 Inspection results – Yards and shed (C2K-19-H8)**

Description		
<p>Location of a structure on a 1927 topographic map (Australian Section Imperial General Staff 1927), and of a site identified as a possible dairy (Site 79) by the previous Jacobs report (Jacobs Group (Australia) Pty Limited 2016). Due to access constraints, Jacobs was not able to inspect the area.</p> <p>The site is located on Lot 94/SP157507, in a low lying area 1 km east of Purga Creek, and 50 m south of an unnamed intermittent creek. Key elements noted include a large hay shed, a set of yards, and the remains of a horse-drawn wagon. A modern metal-clad shed is located to the south of the yards.</p>		
Current imagery	Historical imagery (1944 MAP1539489)

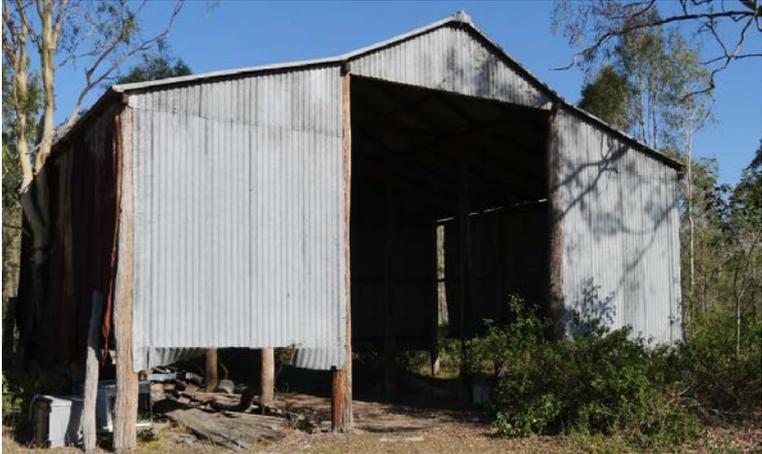
<p><b>Photograph 6.26 C2K-19-H8 shed</b></p>

Key elements		
Shed	Easting (GDA94 Z56)	Northing (GDA94 Z56)
<p>The shed is a large structure, measuring approximately 8 m x 10 m, and is constructed from a mixture of milled and unmilled timber, clad in corrugated iron. The size and shape of the shed suggests it may have been used for storing hay, and historical aerial imagery (MAP1539489) indicates it has been on the site since at least 1944.</p>	475912mE	6925452mN

Criterion	Assessment	Threshold
A – historical	The structures at C2K-19-H8 have the potential to be related to the pastoral industry, but there is insufficient historical or physical evidence to confirm the nature or extent of association.	<input checked="" type="checkbox"/> Not met <input type="checkbox"/> Local <input type="checkbox"/> State
B – rarity	The remains of the delivery wagon have the potential to be rare, although this rarity is diminished by the poor condition.	<input checked="" type="checkbox"/> Not met <input type="checkbox"/> Local <input type="checkbox"/> State
C – research	The removal of many of the early buildings on the site, combined with subsequent construction activities suggests the potential for archaeological remains is low.	<input checked="" type="checkbox"/> Not met <input type="checkbox"/> Local <input type="checkbox"/> State
D – representativeness	The structures at C2K-19-H8 are not sufficiently intact to be a good representative of type.	<input checked="" type="checkbox"/> Not met <input type="checkbox"/> Local <input type="checkbox"/> State

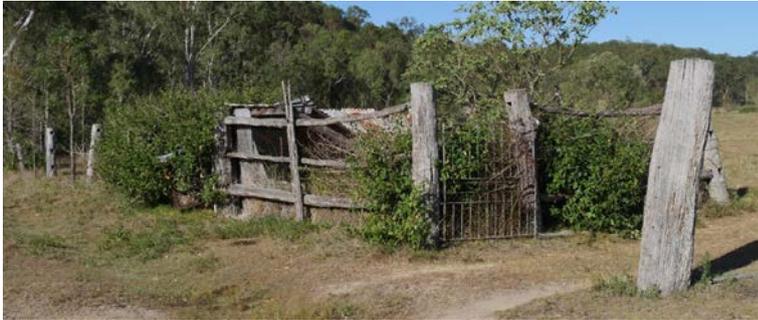
Photograph 6.27 C2K-19-H8 yards

Yards	Easting (GDA94 Z56)	Northing (GDA94 Z56)
<p>The yards are partly collapsed and overgrown with lantana, but appear to measure approximately 6 m x 20 m. The posts are extremely sturdy, and feature the morticing associated with post and rail fencing, a construction method which generally dates to before WWII (Pickard 2005). A few of the original rails remain on the southern side of the yards. In more recent times, the yards appear to have been converted into a small animal enclosure. No evidence was found of a dairy or other structures.</p>	475784mE	6925455mN
	475784mE	6925444mN
	475785mE	6925439mN
	475786mE	6925433mN

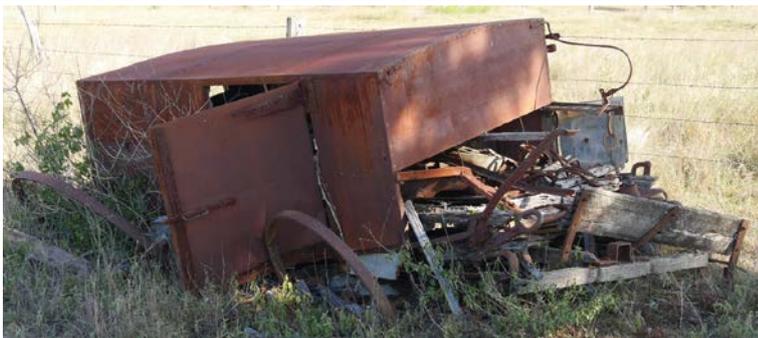
Photograph 6.28 C2K-19-H8 wagon

Wagon	Easting (GDA94 Z56)	Northing (GDA94 Z56)
<p>The remains of a horse-drawn wagon are located 70 m south west of the yards. The wagon is in a state of advanced dilapidation, and the leather and many of the wooden elements have perished. However, the vehicle appears to have decayed in place, and many metal components, including wheel rims and suspension, remain.</p> <p>The bed of the wagon has been enclosed with a timber frame clad in red-painted metal, the interior of which has been horizontally divided by a wooden shelf. There are doors located on the rear and both sides of the wagon, and it was likely a delivery vehicle for perishable goods, such as bread or milk. The interior of the wagon is now filled with refuse, most of which dates to the late 20<sup>th</sup> century.</p>	475730mE	6925381mN

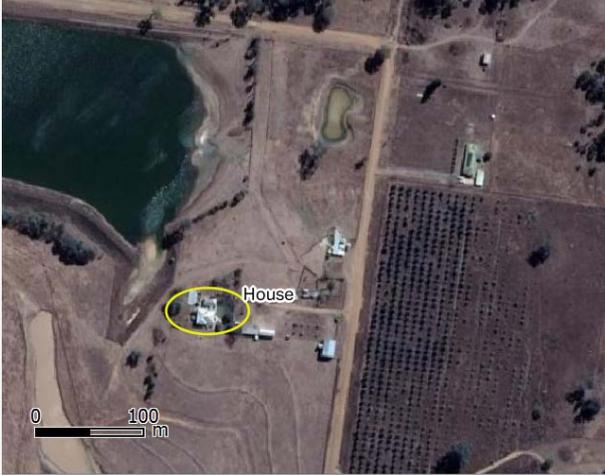
Table 6.10 Inspection results – House (C2K-19-H9)

Description		
<p>Location of multiple structures shown on 1927 topographic map (Australian Section Imperial General Staff 1927). The site on Lot 53/SP148223 could not be inspected due to access constraints, but it would appear to contain a house and a number of out-buildings.</p>		
Current imagery	Historical imagery (1944 MAP1539443)

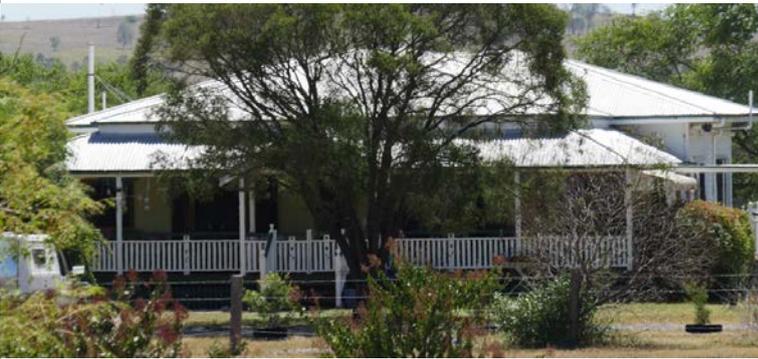
<p>Photograph 6.29 C2K-19-H9 house</p>

Key elements		
House	Easting (GDA94 Z56)	Northing (GDA94 Z56)
<p>The house is a large structure clad in weatherboards with a corrugated iron roof, and appears to have been constructed in at least two phases, with a rectangular rear wing added to an earlier building.</p> <p>The earlier building, now the front half of the house, features a hipped, pyramid roof with a stepped, convex roofed verandah on at least three sides. Such designs were generally constructed in the late colonial period, from the 1880s to the turn of the century (Rechner 1998).</p> <p>Aerial imagery (1970 QAP209815) suggests the later extension was added in the 1960s, which is consistent with the casements windows on this part of the building. During these renovations, the roofline was reconfigured, making the original roof a transverse hip, and the entire structure was reclad. The current roof cladding is in very good condition, suggesting that it has since been replaced at least once.</p>	475511mE	6925173mN

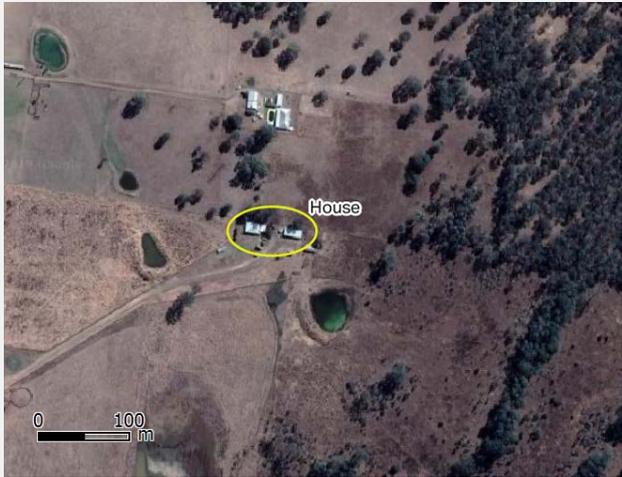
Table 6.11 Inspection results – House (C2K-19-H10)

Description		
<p>Location of multiple structures shown on 1928 topographic map (Australian Section Imperial General Staff 1928). The site on Lot 22/RP22586 could not be inspected due to access constraints, but it would appear to contain a house and a number of out-buildings.</p>		
Current imagery	Historical imagery (1944 MAP1539443)

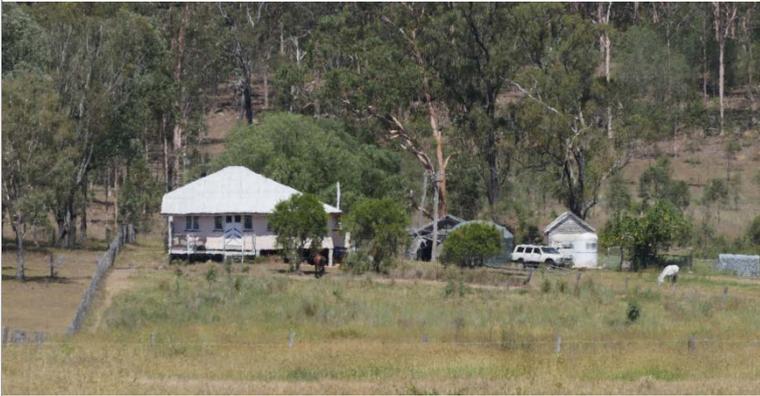
<p><b>Photograph 6.30 C2K-19-H10 House</b></p>

Key elements		
House	Easting (GDA94 Z56)	Northing (GDA94 Z56)
<p>From what could be observed from nearby public areas, the house would appear to be a wooden structure with a hipped roof which is gabled on the northern façade, and extends over an enclosed verandah on the southern side (Photograph 6.30). Windows appear to be casements, and the front door to be partially glazed French doors. This design is consistent with that of the 'Bungalow with L-shaped verandah' which was common in Queensland from 1900-1930 (Rechner 1998).</p> <p>The roof cladding appears in good condition, showing few signs and corrosion, and suggesting that it has been replaced at least once since the building was constructed.</p>	475849mE	6927487mN

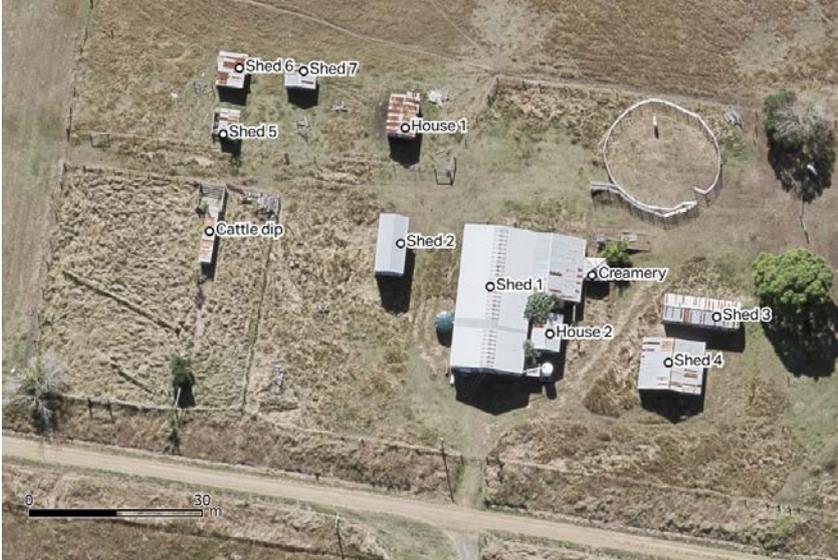
**Table 6.12 Inspection results – Multiple structures (C2K-19-H11)**

Description		
<p>Location of a structure on a 1927 topographic map (Australian Section Imperial General Staff 1927), and of a site identified as a Homestead Complex (Site 68) by the previous Jacobs report (Jacobs Group (Australia) Pty Limited 2016).</p> <p>The site is located on Lot 77/RP218829, in a low-lying area 2 km east of Purga Creek and features 12 buildings ranging from large sheds to small huts. Analysis of historical aerials suggests that only two of these buildings – the Creamery and House 1 – are original to the site.</p> <p>The remainder of the buildings have been constructed on or relocated to the site since the late 1960s. This interpretation was borne out by the site inspection, during which some buildings were noted to be blocking the entrances to others.</p>		
Current imagery

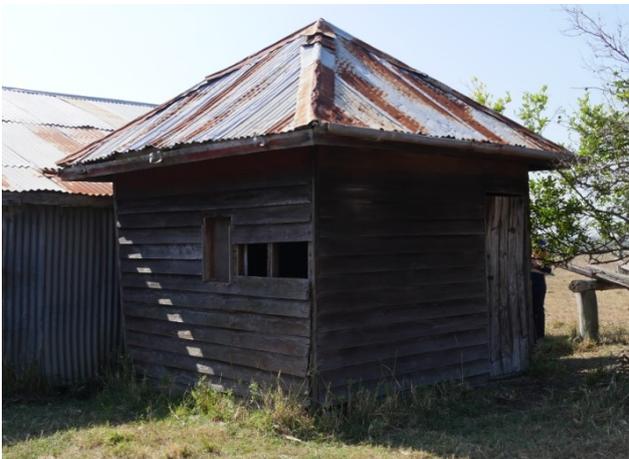
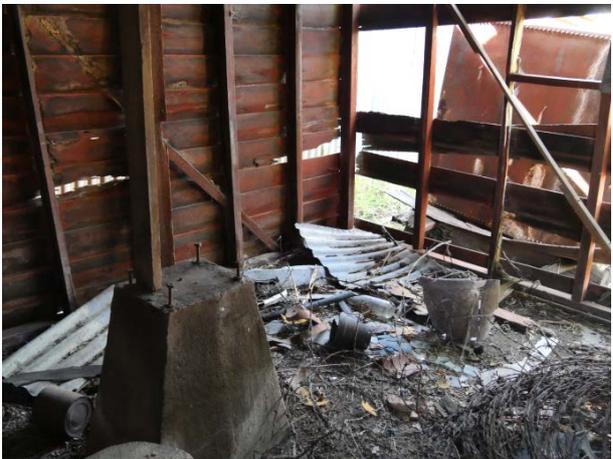
<p><b>Photograph 6.31 C2K-19-H11 creamery exterior</b></p>	<p><b>Photograph 6.32 C2K-19-H11 creamery interior</b></p>

Key elements		
Creamery	Easting (GDA94 Z56)	Northing (GDA94 Z56)
<p>The creamery is of very similar construction to that at C2K-19-H6, measuring approximately 4.5 m x 4.5 m, with a corrugated iron hipped roof. The frame is of milled timber, the cladding of weather boards, and the floor is concrete. There is a concrete block to one side of the floor that appears to have been used to mount machinery – likely the milk separator. As noted, the creamery appears to be one of only two pre-1940s building at the site, and it is in poor condition.</p> <p>A ship's tank has been placed on the northern side of the building to act as a rainwater tank.</p>	474369mE	6929878mN

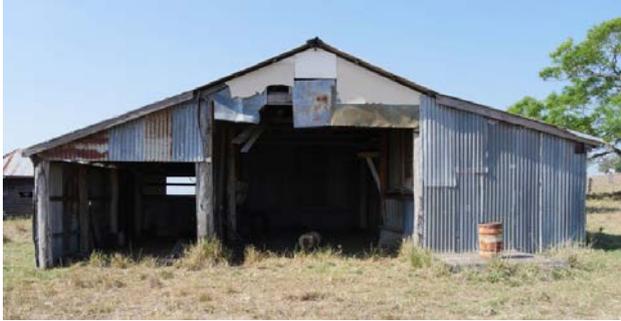
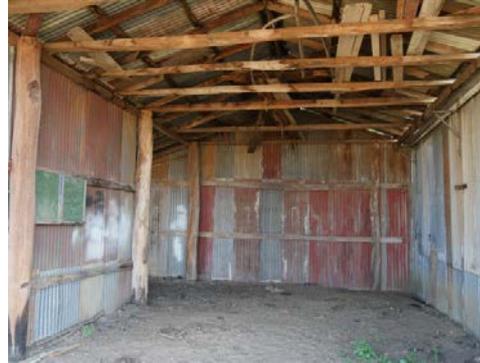
Photograph 6.33 C2K-19-H11 shed 4 exterior

Shed 1, 2, 3 and 4	Easting (GDA94 Z56)	Northing (GDA94 Z56)
Sheds 1-4 are all large structures, suitable for hay or machinery storage, framed with a mixture of milled and unmilled timber, and clad in corrugated iron. Aerial imagery suggests Sheds 1, 2 and 4 were built in the 1960s (QAP0798073, QAP2066013), and Shed 3 in the 1970s (QAP28841172). All of the buildings appear to be structurally sound, although the cladding is failing or missing in a number of locations.	474353mE	6929871mN
	474335mE	6929882mN
	474387mE	6929870mN
	474383mE	6929859mN

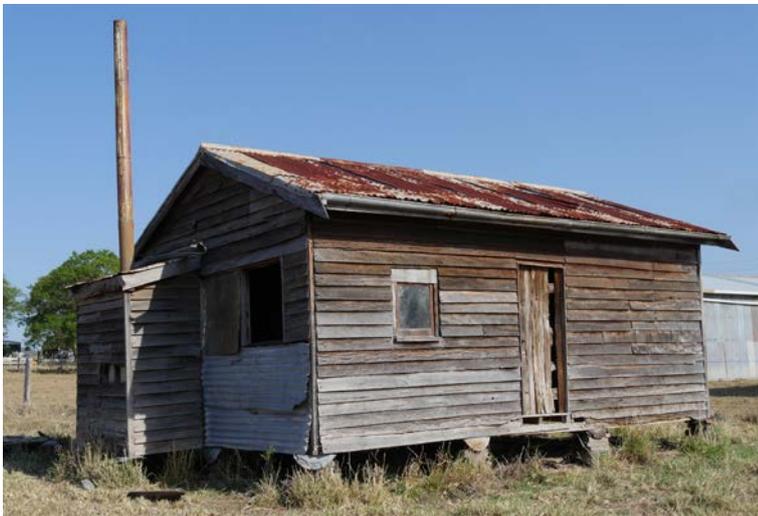
Photograph 6.35 C2K-19-H11 house1 exterior

House 1	Easting (GDA94 Z56)	Northing (GDA94 Z56)
House 1 is a small, single room timber framed building clad in weatherboards and featuring a corrugated iron gable roof, and measures approximately 5 m x 7 m. A skillion-roofed stove alcove extended from the northern side of the building. The building currently rests on small wooden stacks, suggesting that restumping or relocation was planned. Most of the windows have been removed, the glazing replaced with corrugated iron, and the building is in poor condition. As noted, House 1 appears to be one of only two pre-1940s building at the site.	474336mE	6929903mN

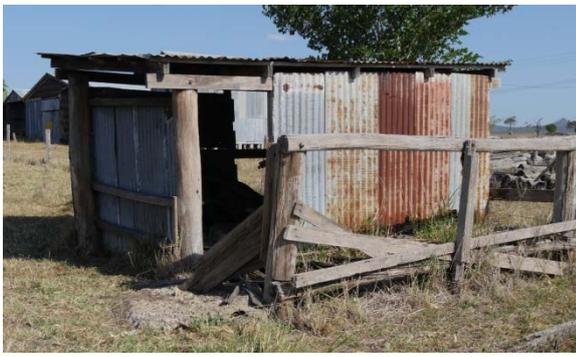
Photograph 6.36 C2K-19-H11 shed 5 exterior

Shed 5 and 6	Easting (GDA94 Z56)	Northing (GDA94 Z56)
Sheds 5 and 6 are small structures with frames of milled and unmilled timber, and clad in corrugated iron. Both appear to have been used most recently as animal shelters. Aerial imagery suggests Shed 5 was constructed in the early 1970s, and Shed 6 in the late 1970s or early 1980s. Given the mixture of construction materials, it seems likely both were built at least partly from materials scavenged from the site or elsewhere.	474306mE	6929903mN
	474307mE	6929912mN

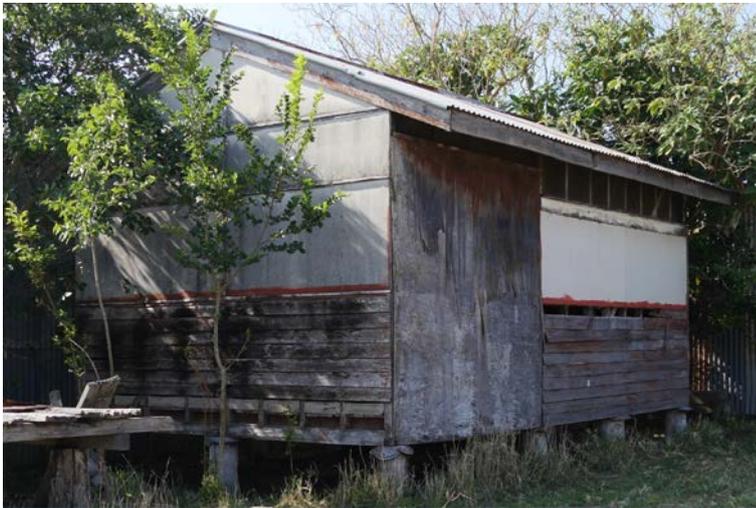
Photograph 6.38 C2K-19-H11 house 2 exterior

House 2 is located in a small space next to Shed 1, which partly blocks the entrance to the dwelling. The building is timber framed, with a corrugated iron gable roof, and measures some 5 m x 6 m. The original cladding was of weatherboards, but these have been replaced in several places with sheeting. The building is in very poor condition.

Aerial imagery suggests the building was built or moved to this location in the early 1970s (QAP28841172).

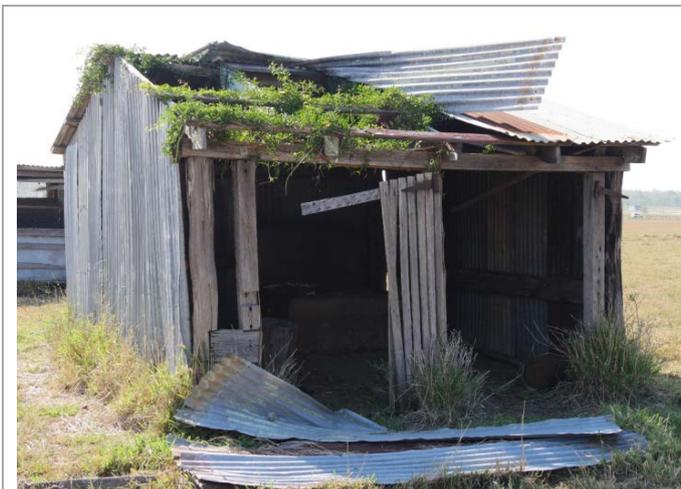
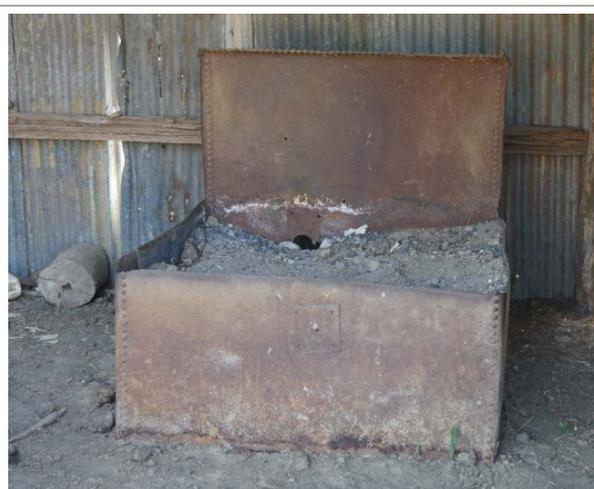
Photograph 6.39 C2K-19-H11 shed 7 exterior		Photograph 6.40 C2K-19-H11 shed 7 interior	
<b>Cattle dip</b>		<b>Easting (GDA94 Z56)</b>	<b>Northing (GDA94 Z56)</b>
The cattle dip consists of a narrow, deep, concrete lined channel, over which a milled timber and corrugated iron structure has been erected. A small set of yards are located at the northern end. Historical aerials suggest the dip was constructed in the early 1970s (QAP28841172).		474302mE	6929884mN
