# Non-Indigenous Heritage Technical Report

CALVERT TO KAGARU ENVIRONMENTAL IMPACT STATEMENT

# **Inland Rail Calvert to Kagaru EIS**

Appendix T – Non-Indigenous  
Heritage Technical Report

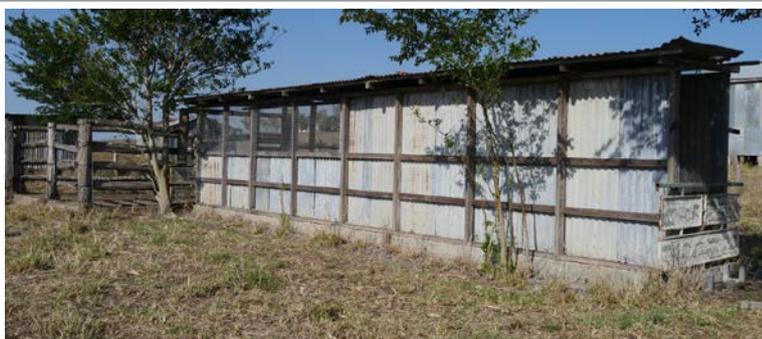
Photograph 6.41 C2K-19-H11 dip exterior

Photograph 6.39 C2K-19-H11 shed 7 exterior		Photograph 6.40 C2K-19-H11 shed 7 interior	
<b>Cattle dip</b>		<b>Easting (GDA94 Z56)</b>	<b>Northing (GDA94 Z56)</b>
The cattle dip consists of a narrow, deep, concrete lined channel, over which a milled timber and corrugated iron structure has been erected. A small set of yards are located at the northern end. Historical aerials suggest the dip was constructed in the early 1970s (QAP28841172).		474302mE	6929884mN

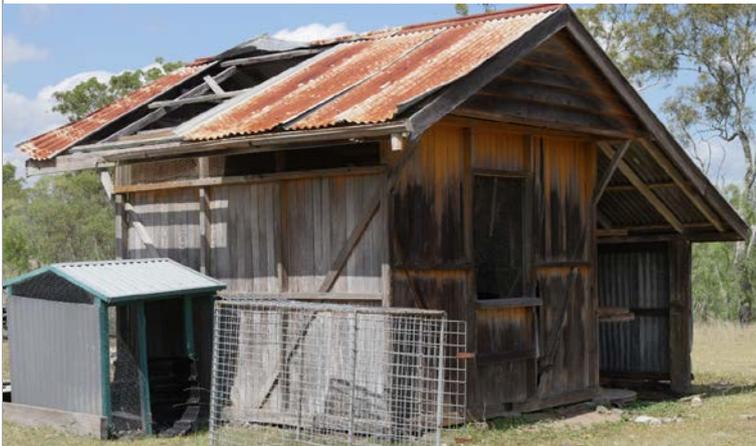
Photograph 6.42 C2K-19-H12 creamery

Key elements		
Creamery	Easting (GDA94 Z56)	Northing (GDA94 Z56)
<p>The creamery is of a slightly different construction to that identified at C2K-19-H11 and C2K-19-H6, featuring a gable rather than hipped roof. However, the overall size is very similar – 4.5 m x 4.5 m – as is the concrete floor, internal tongue and groove internal cladding and the exposed exterior studs. As with the other creameries, the wall cladding does not extend the full height of the structure, leaving a gap for ventilation under the eaves.</p> <p>At some point, a skillion roof has been added to the western side of the building, creating a lean-to. The overall structure is in fair condition.</p>	461155mE	6936980mN

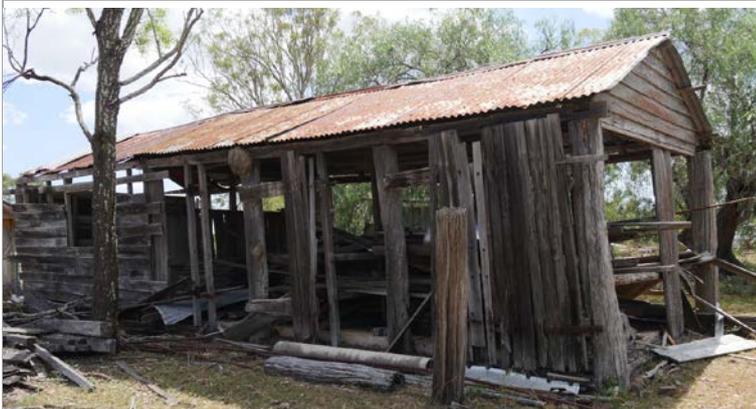
Photograph 6.43 C2K-19-H12 dairy exterior

Dairy	Easting (GDA94 Z56)	Northing (GDA94 Z56)
<p>The likely dairy is a long structure, measuring some 10 m x 4 m, and appears to have been constructed in two distinct phases (Photograph 6.43). The earliest phase is that of a slab hut, which occupies what is now the southern-most half of the building (Photograph 6.44). Pieces of slab walling remain on both the southern and northern sides of the original hut (the latter now being an internal wall) (Photograph 6.45).</p> <p>At some later point, the building has been extended, creating the current 10 m length, and the floor of the original hut in-filled with concrete. The extension features a milled timber frame with weatherboards, and the whole structure has a corrugated iron gable roof.</p> <p>Given the presence of the nearby creamery (and the prevalence of dairying in this area) it seems likely that the renovation of the slab hut was undertaken to convert the space into a dairy. The structure is in poor condition.</p>	461155mE	6936966mN

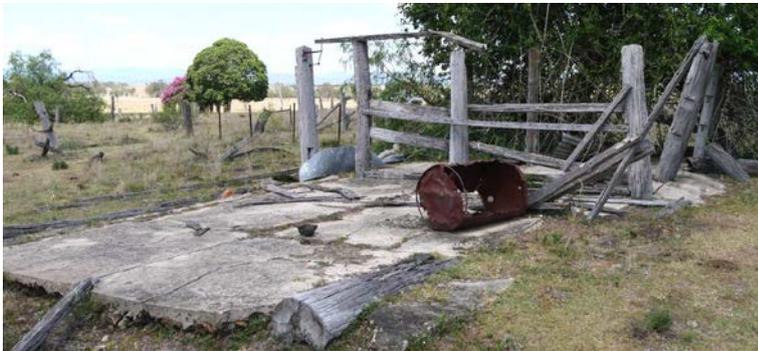
**Photograph 6.46 C2K-19-H13 dairy**

Dairy and yard	Easting (GDA94 Z56)	Northing (GDA94 Z56)
<p>The dairy is located on 256/CH3159, on the northern side of Paynes Road, and consists of a concrete slab approximately 9 m x 5 m, with a long concrete drain running downhill from the south east corner (refer also C2K-19-H1). Milled and unmilled timber has been used to create an enclosure, and possible milking bail at the western end (Photograph 6.46). The eastern end appears to have been more open, and the remains of a milk separator – including both centrifugal pump and bowl – were identified in this area (Photograph 6.47). The kettle-like shape of the bowl is consistent with separators manufactured after 1913 (Arnold 1999) while the pump, manufactured by Kelly &amp; Lewis Ltd, dates to after 1940 (Moore n.d.). Aerial imagery indicates that the dairy was standing, and possibly in use, into the 1980s.</p> <p>The dairy is surrounded by the remains of a post and rail yard, a type of construction that generally dates to before WWII (Pickard 2005) Photograph 6.48. The fence extends 10 m to the north of the dairy, 15 m to the south, and 30 m to the east. A gate and area of sandstone paving is located in the centre of the eastern fence (Photograph 6.49).</p>	459917mE	6937351mN

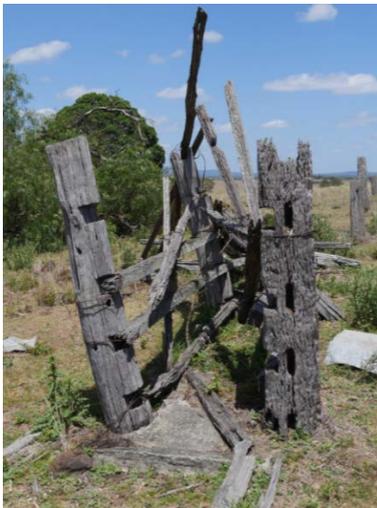
Photograph 6.50 C2K-19-H13 crush

Cattle yards and crush	Easting (GDA94 Z 56)	Northing (GDA94 Z56)
The cattle yards and crush are located 20 m south of the dairy, on the opposite side of Paynes Road (Photograph 6.50, Photograph 6.51). The yard measures 20 m x15 m and features a combination of post and rail and wire fencing. The cattle crush, which is located at the western end of the yard, similarly mixes old and new building methods.	459912mE	6937314mN

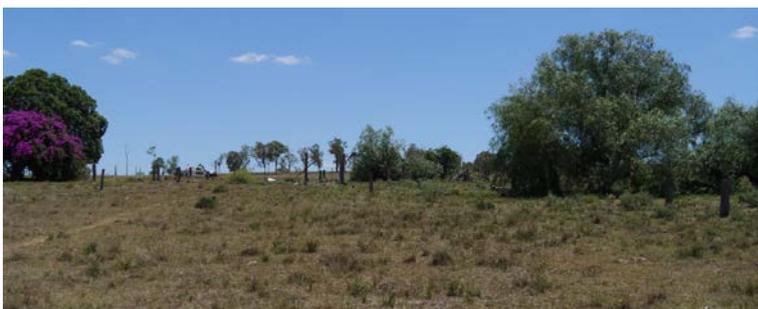
Photograph 6.52 C2K-19-H13 possible house site

Possible house site	Easting (GDA94 Z56)	Northing (GDA94 Z56)
The possible house site is marked by a wide array of building, domestic and garden remnants (Photograph 6.52). These include housing stumps and an area of sandstone paving, bed frames and parts of a refrigerator, bougainvillea bushes and peppertrees ( <i>Schinus molle</i> ).	459856mE	6937304mN

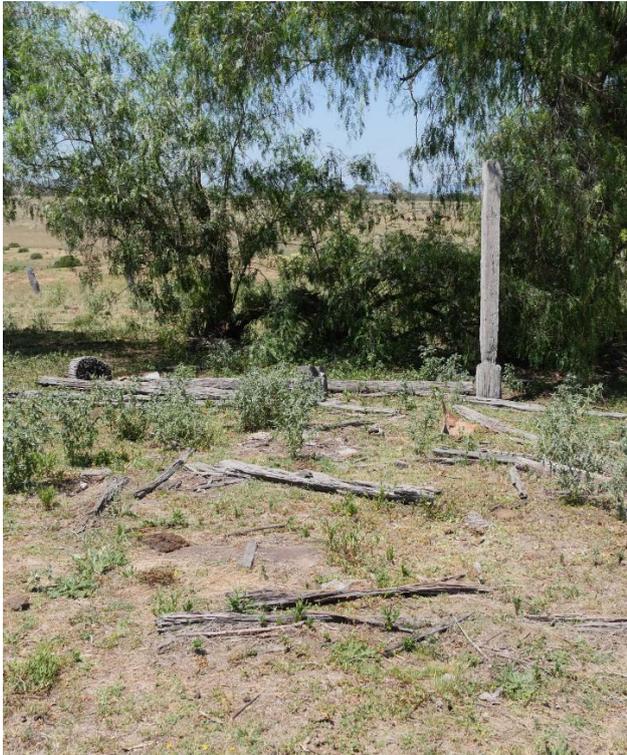
Photograph 6.53 C2K-19-H13 possible shed site

Possible shed site	Easting (GDA94 Z56)	Northing (GDA94 Z56)
The possible shed site is marked by peppertree, two slightly raised earthen pads, a number of building stumps and posts, and an array of metal artefacts, including the suspension from a cart or wagon (Photograph 6.53, Photograph 6.54).	459889mE	6937280mN

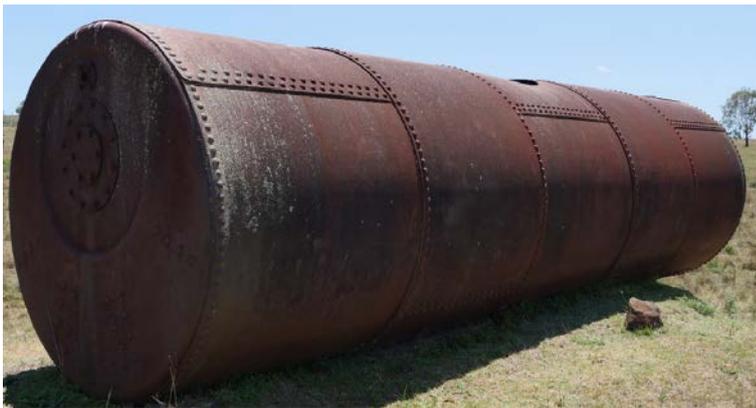
Photograph 6.55 C2K-19-H13 boiler tank

Boiler tank	Easting (GDA94 Z56)	Northing (GDA94 Z56)
A large boiler tank, measuring some 6 m, is located to the south of the site, next to a dam, and was likely used to provide water to the nearby yards (Photograph 6.55).	459918mE	6937248mN

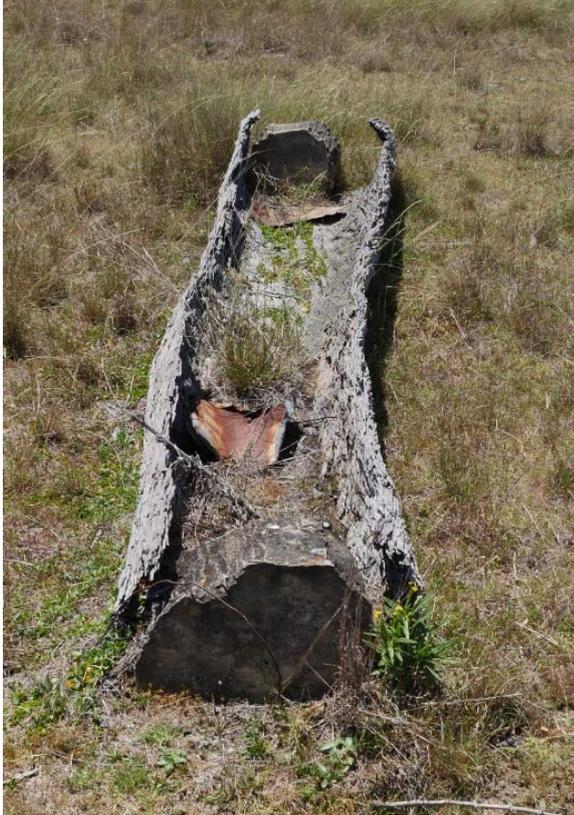
Photograph 6.56 C2K-19-H13 trough

Makeshift troughs	Easting (GDA94 Z56)	Northing (GDA94 Z56)
<p>Two troughs, made from hollow logs capped with concrete, were noted to the east of the dairy yard (Photograph 6.56). It seems likely that these were used to provide cattle with molasses, a drought relief food (Alexander 1978). A more typical molasses delivery apparatus – a drum lick – was noted in another paddock (Photograph 6.57).</p>	459964mE	6937301mN
