# Paradise Dam Upgrade Options Assessment

Independent Design, Cost and  
Risk Review

**Building Queensland**

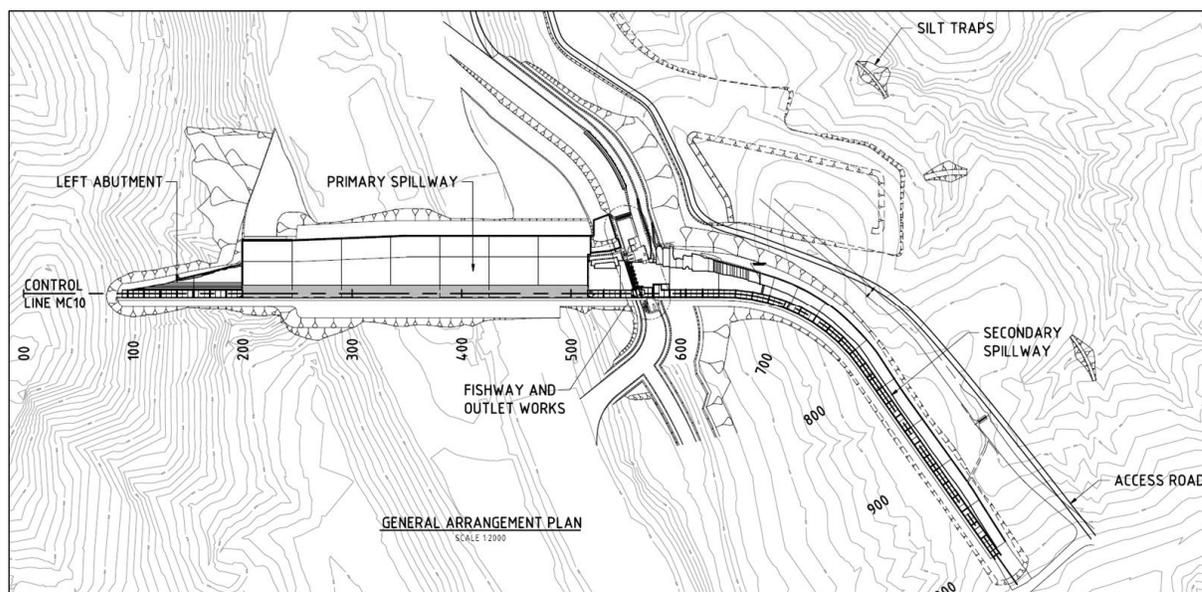
**Figure 1 General arrangement of Paradise Dam (extract from drawing BDA-D-C-008)**

Paradise Dam is a concrete gravity structure that was constructed primarily using roller compacted concrete (RCC) as construction material. The dam wall comprises three zones, i.e. (1) the primary spillway, which spans the Burnett River, is 315 m long and up to 38 m high above the lowest foundation level, (2) the secondary spillway, which is situated on the right abutment, is 485 m long and up to 48 m high, and (3) the left abutment closing wall is 120 m long and up to 53 m high. The sections of the dam are labelled as monoliths according to the transverse cracks induced in the RCC. Three monoliths (labelled A, B and C) form the left abutment, seven monoliths (labelled D, E, F, G, H, J and K) form the primary spillway (each being 45 m wide), and twelve monoliths (labelled L to W) form the secondary spillway.

The general arrangement of Paradise Dam is shown in Figure 1.

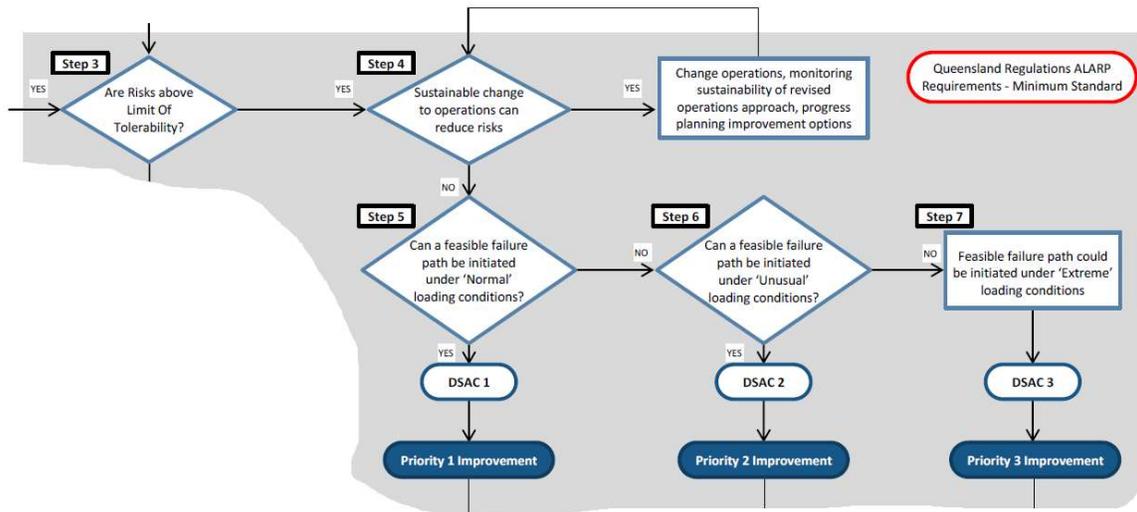
- a) The 41-page document was reviewed, and the process found to be generally in line with contemporary practices recommended by ANCOLD, ICOLD and DRNME.
- b) The only portion of the process that could be reviewed, is the flow diagram for Steps 3 to 7 (see extract below from the flow diagram in Appendix B of the SunWater (2018)). The questions under Steps 5, 6 and 7 can all be answered at the same time using the outcomes of a risk assessment which is used to answer the question for Step 3. Steps 5, 6 and 7 should follow Step 3, before moving to Step 4. If a feasible failure part can be initiated under Normal loading conditions, and a change to the operating conditions could reduce the risk, it should be implemented regardless of whether it is considered sustainable.

Figure 2 Extract from Dam Safety Improvement Decision Criteria (2018 flowchart)

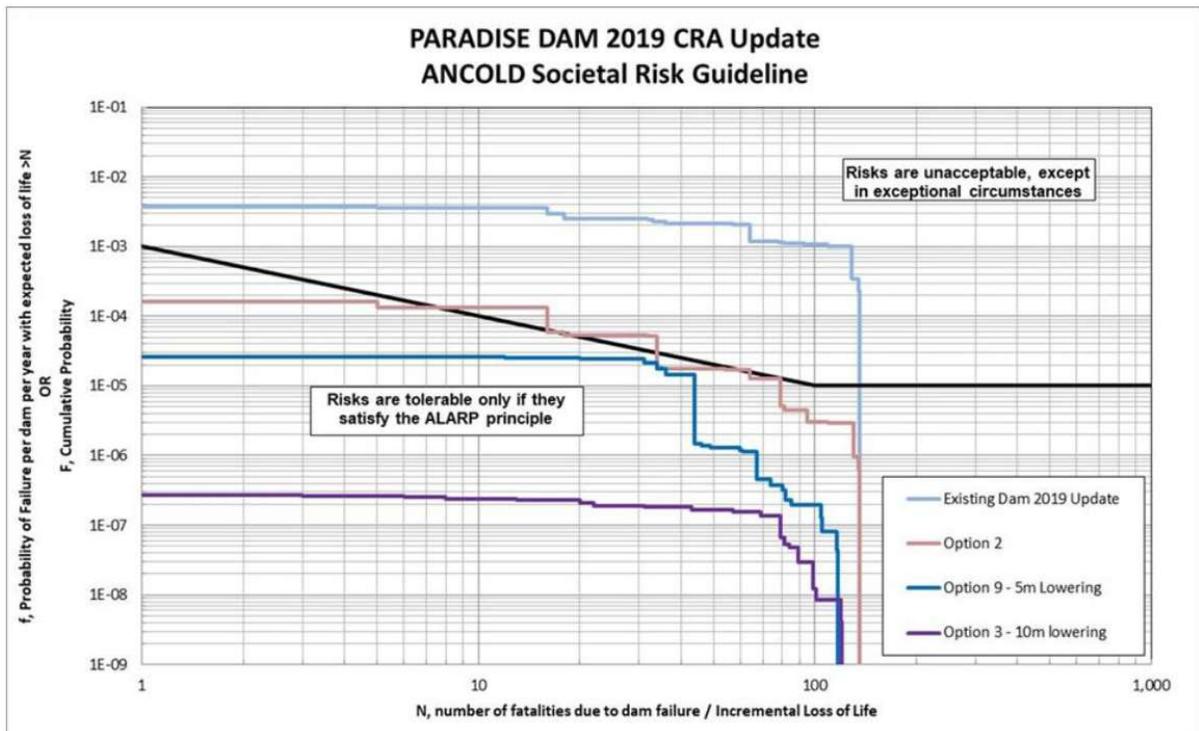
Figure 3 FN-plot for upgrade options (from GHD 2020)

Note, in Figure 3, Option 1 is labelled as Option 2, and Option 2 is labelled as Option 9.

- g) The latest FN-plots (GHD 2020) for the options are shown below.
